# Consideration of Adaptive Reuse of Existing Dwelling and Outbuilding at Barkhill, Woodford, Co. Galway

July 2024  
GCC/HC/CMD

## 1.0 Introduction

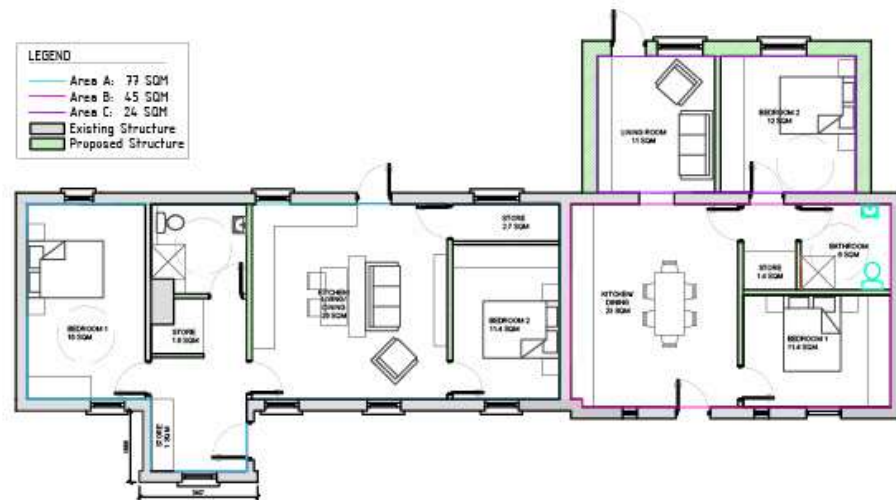
**02 GROUND FLOOR PLAN (PROPOSED ADAPTIVE REUSE STUDY)**  
SCALE 1:150 @ A4

The study of the existing buildings proposes to provide the 2 no. units required using the original split between the dwelling and the outbuilding. Unit A is accommodated in the original cottage to the South while Unit B is accommodated in the original out building to the North.

Unit B is 45 SQM at ground floor level, significantly lower than the required Department standard. The first floor level is currently inaccessible and would not satisfy the accommodation requirements in terms of accessibility for provision of a universal design accessible 2 bed unit. In order to provide the required accommodation an extension to the rear of the existing outbuilding would be necessary. The plan study in Figure 1 below demonstrates a 24 SQM extension to the rear of the existing outbuilding allowing for accommodation of a UD 2 bed level access unit in accordance with requirements.

Figure 1 - Plan study of potential adaptive reuse of existing buildings
