# **BAT AND SWIFT SURVEYS AT DUNLO HILL TERRACE, DOOLEY'S PUB AND ADJOINING PROPERTY, BALLINASLOE, CO. GALWAY**

## **Report Prepared for**

OBFA Architects,  
1 Johnson Place,  
Dublin 2

**October 2022**

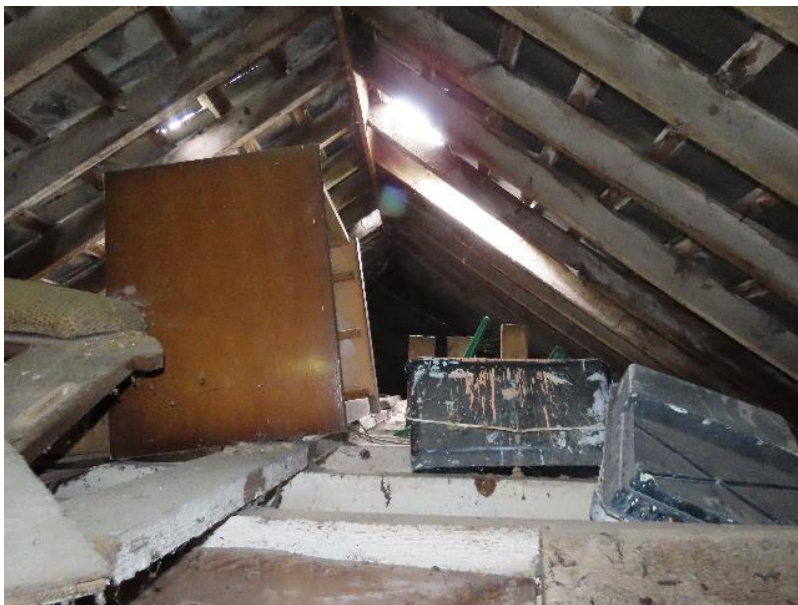
**Photo 33** - Attic of Property 4 with void in roof

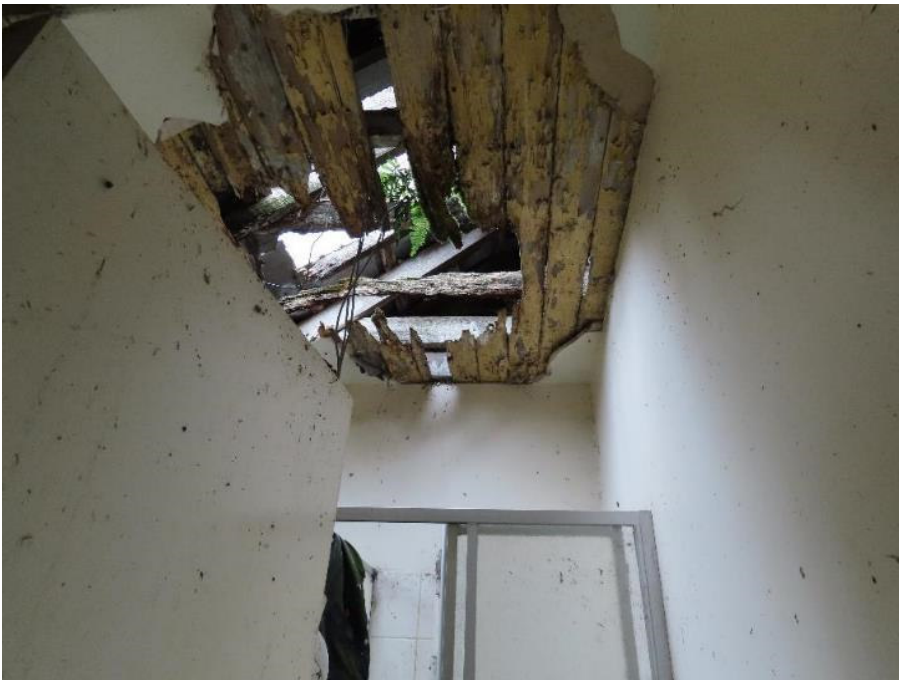
**Photo 38** – damage to ceiling in Property 6

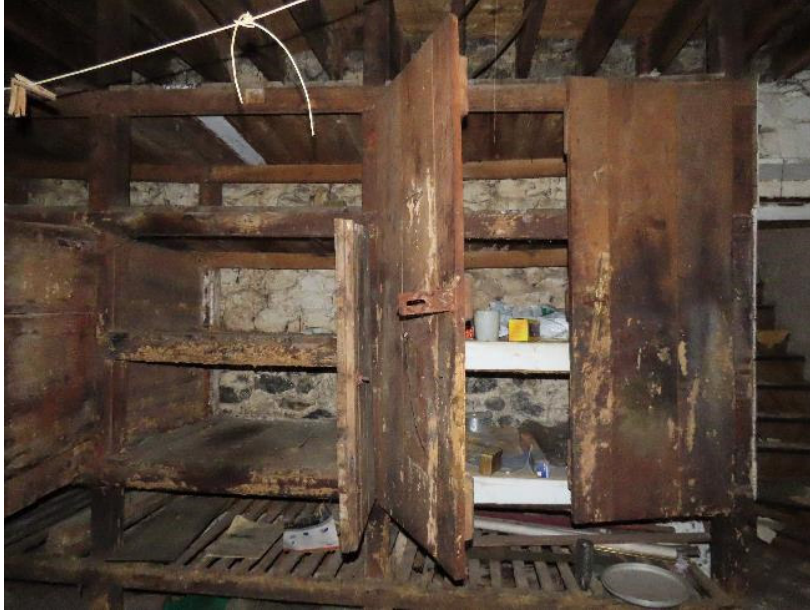
**Photo 53** – basement in P.Dooley's

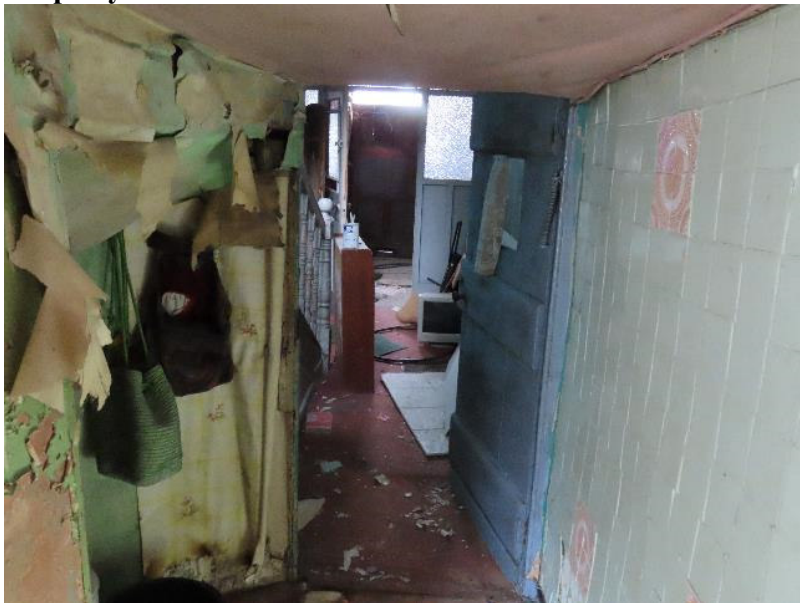
**Photo 55 – hallway of Property 9**

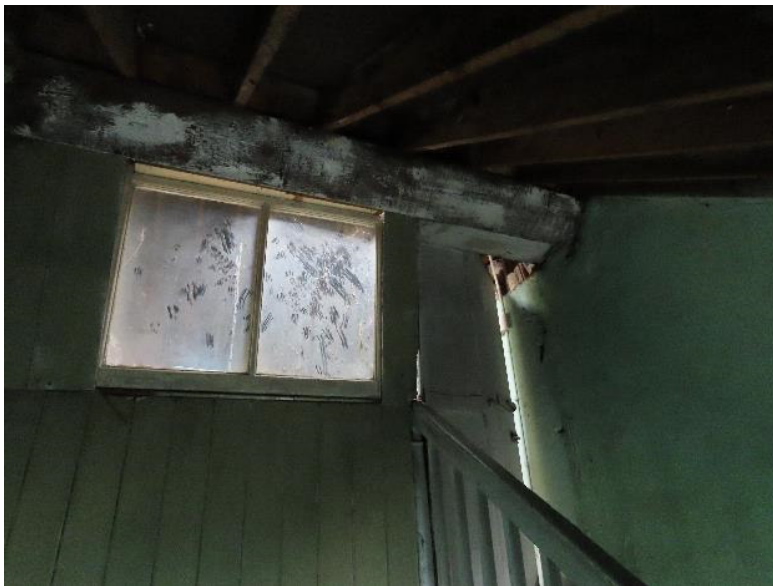
**Photo 58** – stairs to attic space

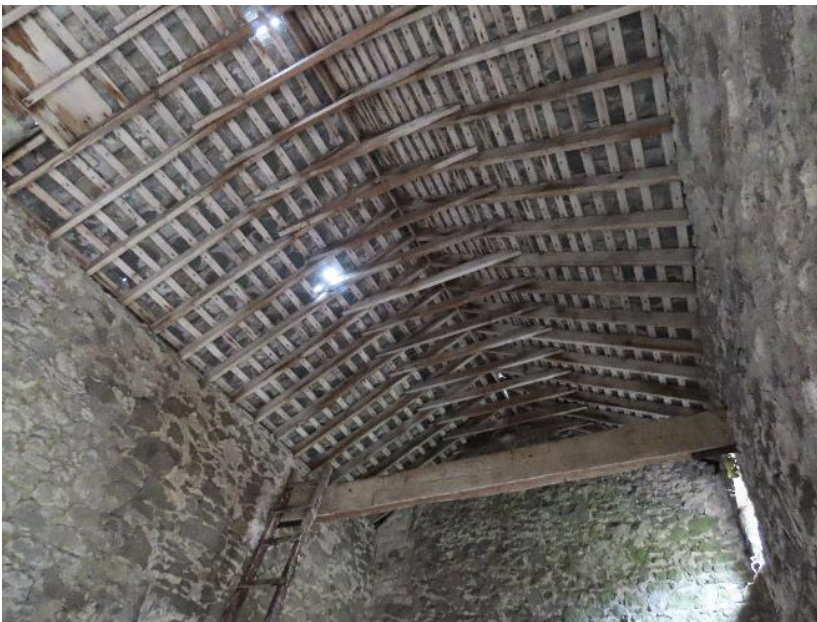
**Photo 62** – exposed roof timbers in outbuilding

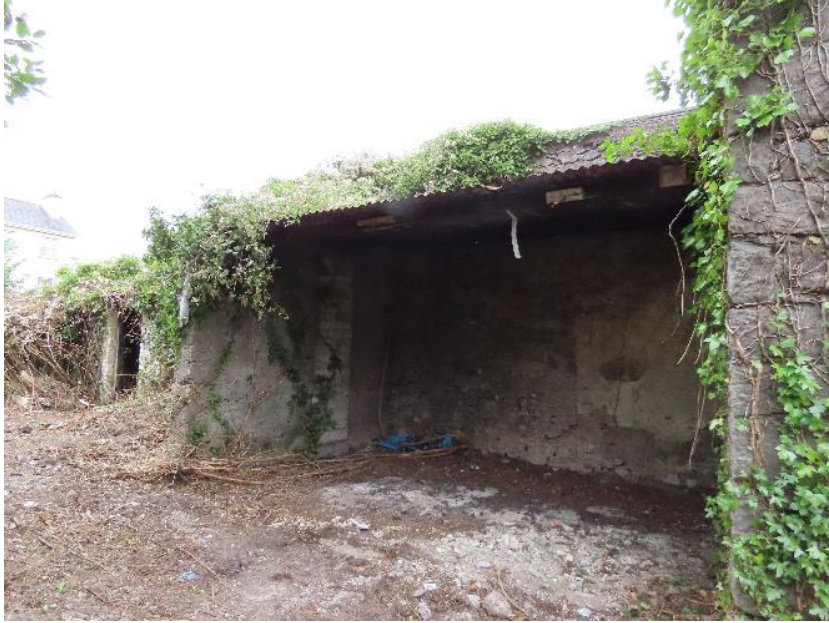
**Photo 63 – lean-to building attached to stone outbuilding**

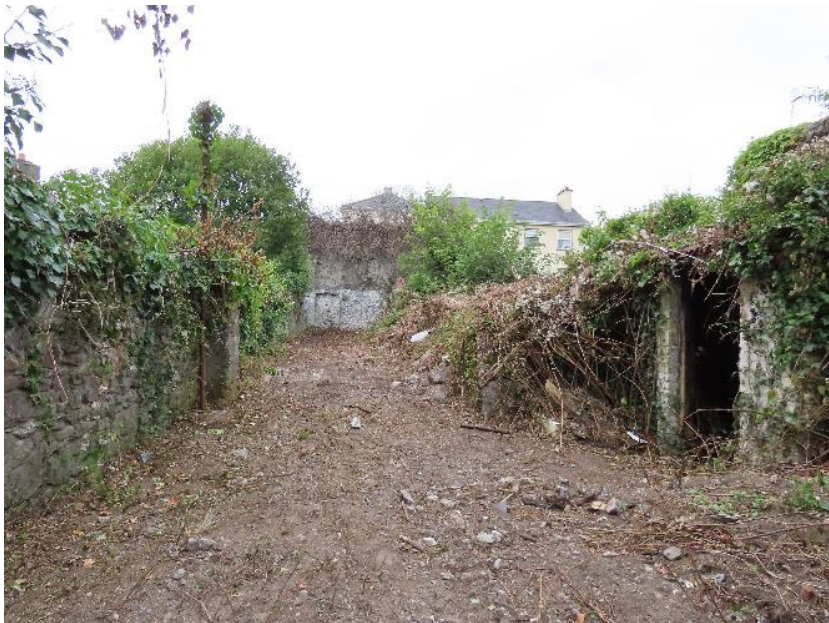
**Photo 64 – looking west towards rear boundary wall**
