## Building Conservation Assessment

Vicar Street, Tuam, Co. Galway

**Client:** Galway County Council, Housing Department

**Date:** 10<sup>th</sup> September 2024

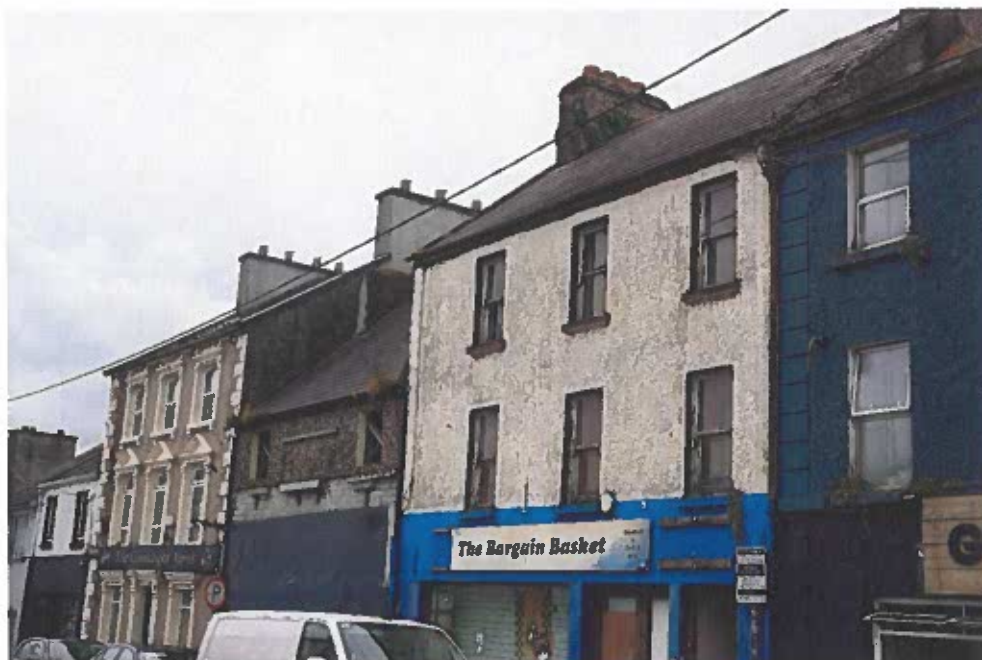
Photograph 1 - View of Subject Structures, Building A to Left, Building B (The Bargain Basket) to Right

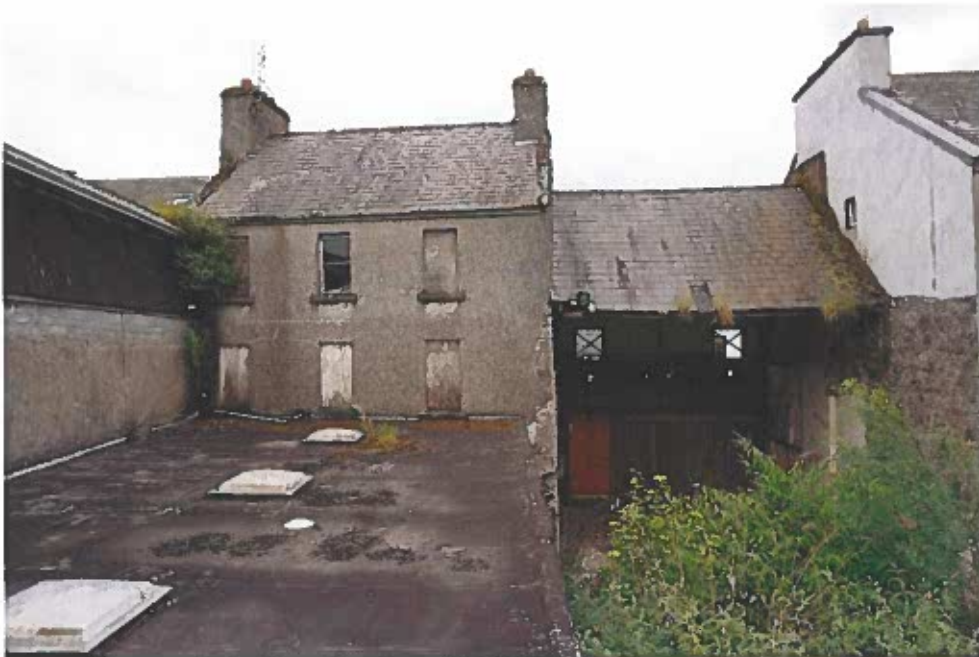
**Photograph 2 - Rear Elevation of Building B (Left) and Building A (Right)**

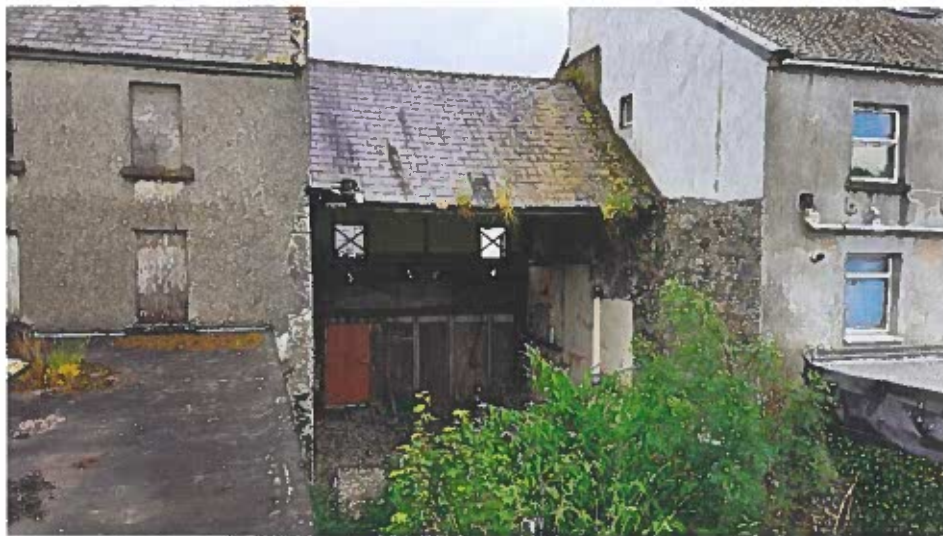
Overall, the roof of Building "A" is holding up and remains intact, despite the lack of a rear structural wall (the roof system here supported by the party walls).

**Photograph 7 Roof of Building "A". Rear elevation, only supported by the party walls.**

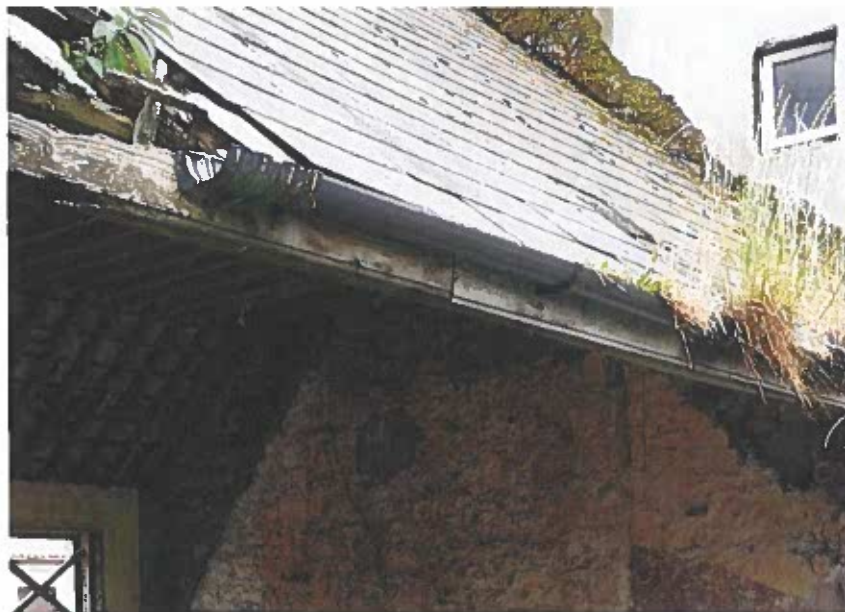
There is a mix of modern seamless aluminium and galvanised steel rainwater goods present on the subject building.

**Photograph 9** Plastic guttering to rear roof eaves.

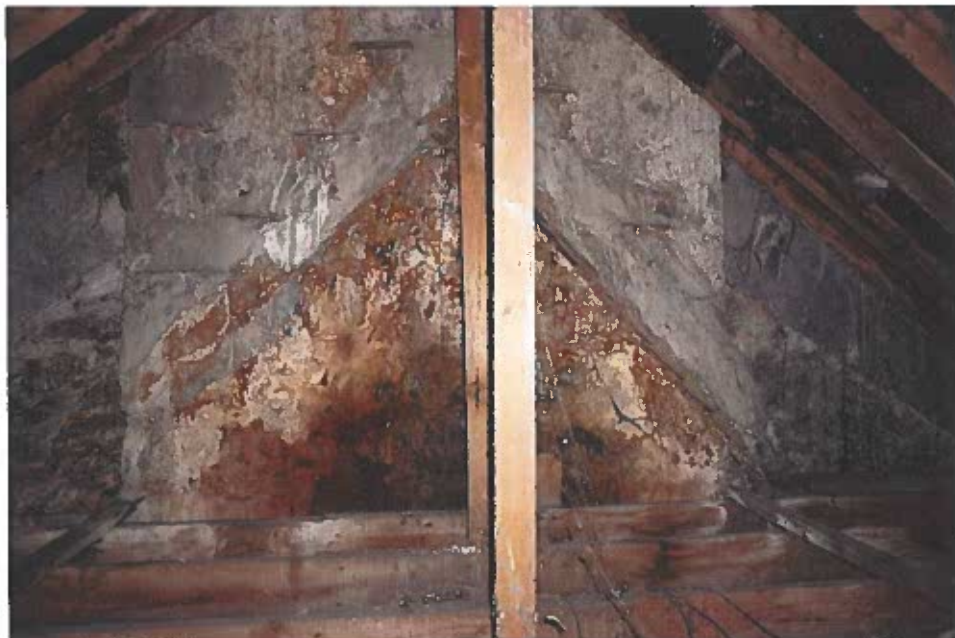
Photograph 13 View chimney system within the roof space.

Within the attic void, the masonry of both systems is viewable, with notable migration of soot from within the system notable. Structurally, both systems appear in good order.

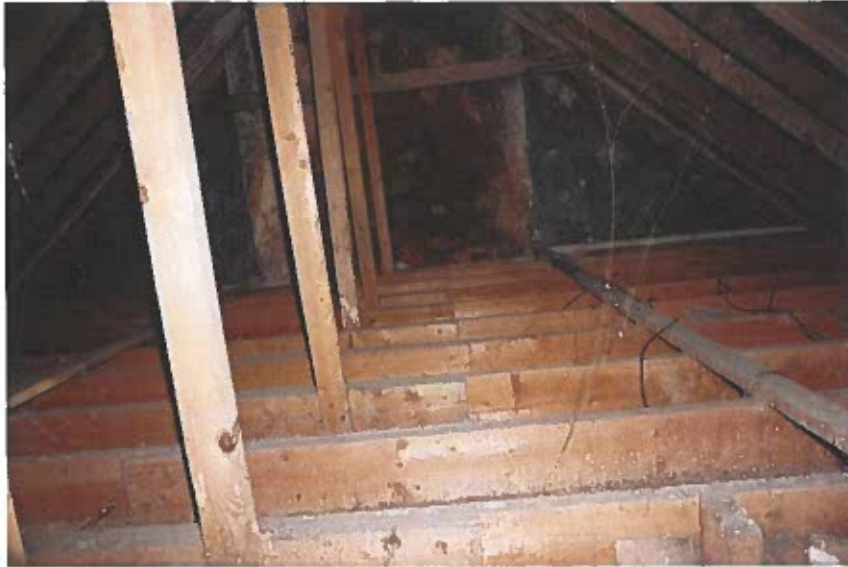
**Photograph 14 View of chimney system within the roof space. Note migration of soot to the external face of the chimney liner masonry.**

The roof structure is of modern sawn timbers in a cut roof, most likely dating from the mid to late twentieth century, not original to the building (see *Photograph 14* View of chimney system within the roof space. Note migration of soot to the external face of the chimney liner masonry. above). The same is true for the ceiling joists, viewable within the attic space. The natural slate covering present was most likely reused from the original covering.

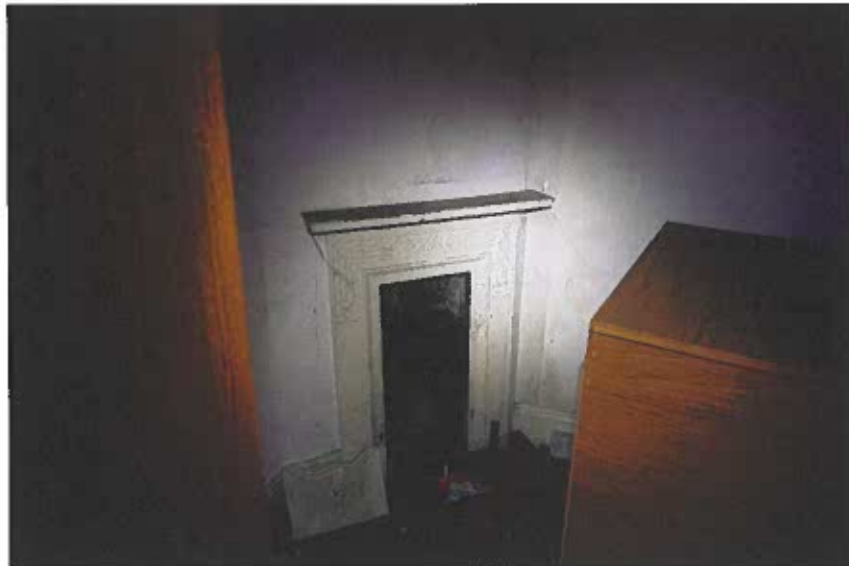
**Photograph 15 Fireplace within first floor bedroom.**

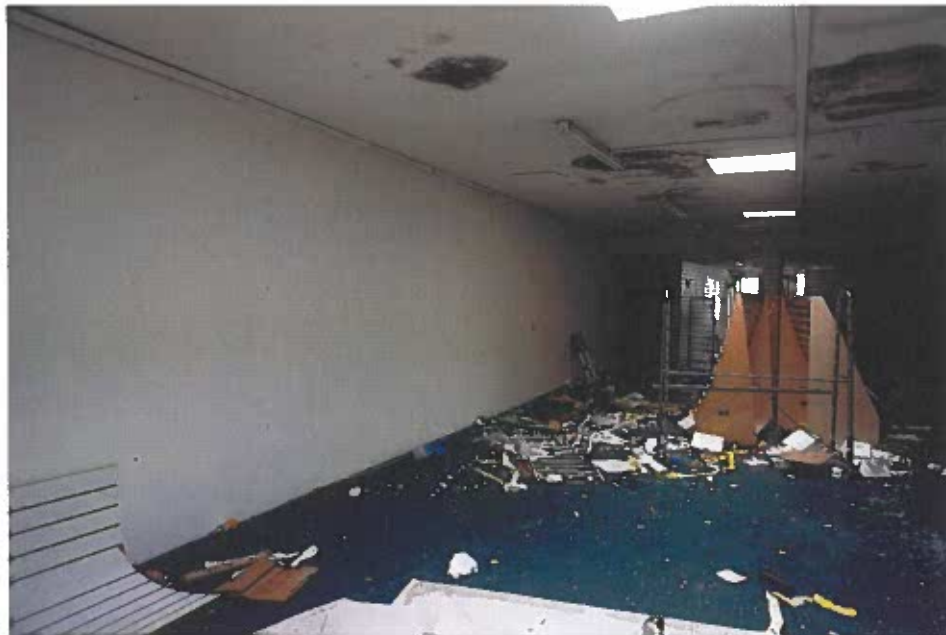
On the ground floor, the shop extends beyond the footprint of the original building. A column (material unknown as boarded up) sits in the centre of the shop space beneath the rear wall of the original building. This column along with the gable walls support a beam (assumed, again material unknown as covered over by the ceiling material) which hold up the structural walls of the upper level of the original building's external walls.

**Photograph 22 Internal view of the shop.**

The ceilings of the first floor of building “B” appear in good repair, while the ceiling of the ground floor shop show signs of continuous water ingress (see *Photograph 22* Internal view of the shop. above).

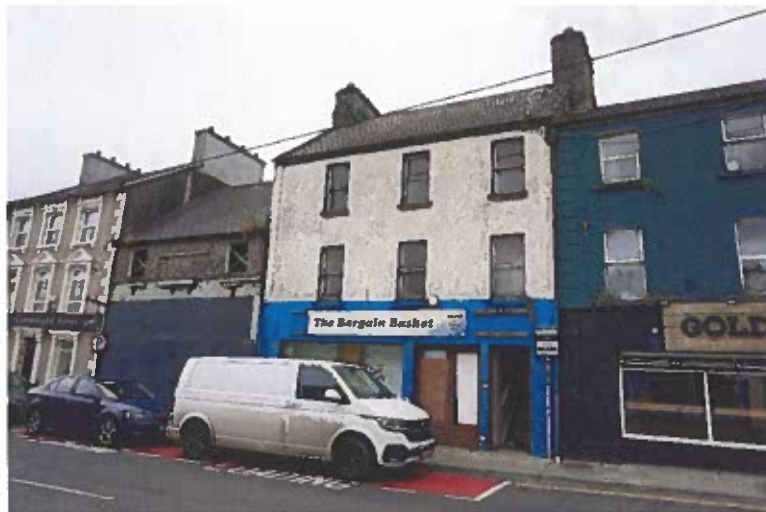
The window and door assemblies are a mixture of traditional sash up down window assemblies and modern timber top hung casement assemblies with the shop front a modern style and finish.

**Photograph 23 Front fenestration of building “B”.**

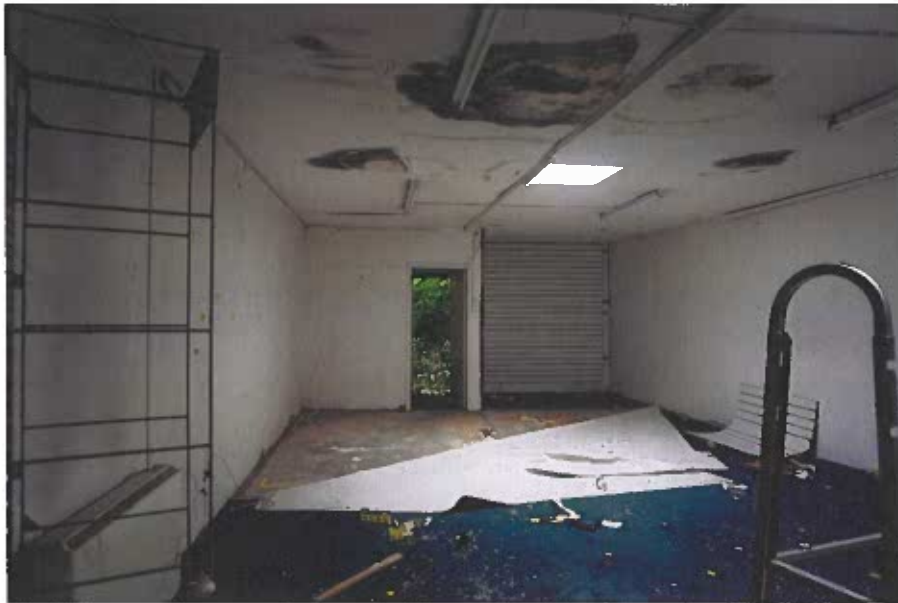
**Photograph 25** View to the rear of the ground floor of building "B", with the floor finish pulled back revealing the concrete floor.

The ground floor is a concrete installation.
