Farranamartin, Tuam

Co. Galway

Stage 1

Road Safety Audit

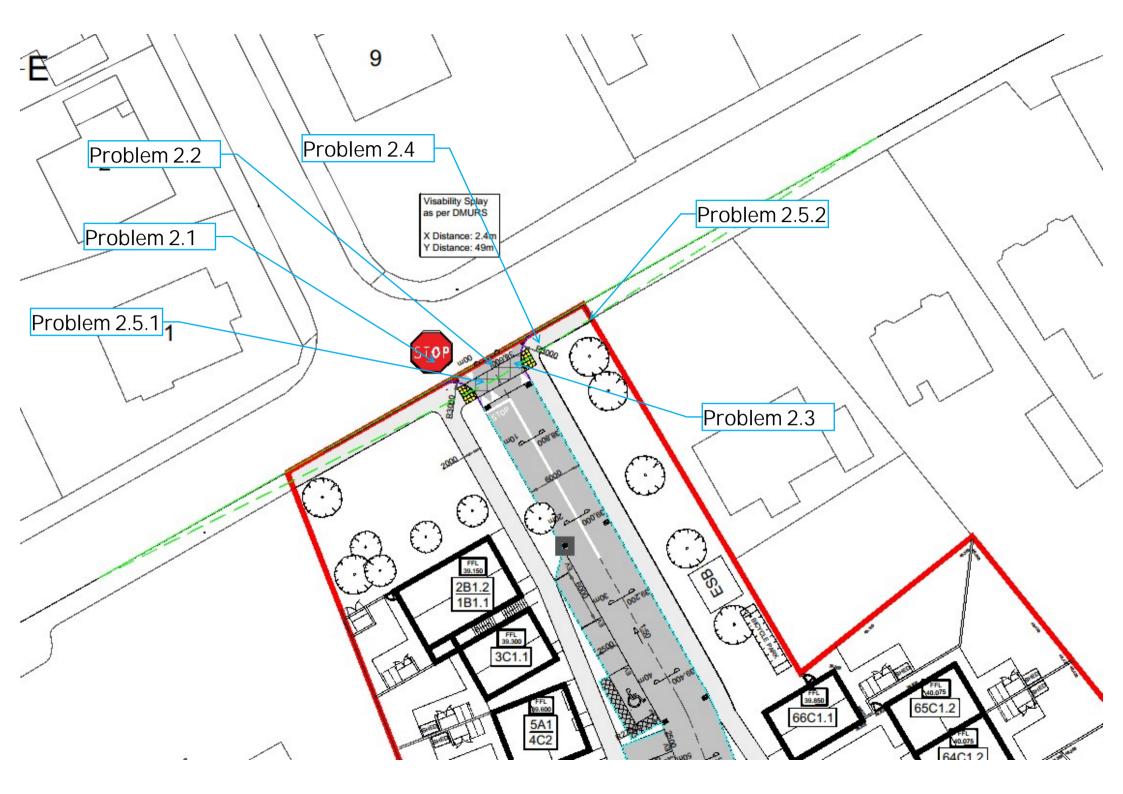
Appendix A-II PROBLEM MAP

The Audit Team observed onsite the existing environment along the R939 (Galway Road). The Audit Team are concerned about volume of traffic potentially turning right into the proposed estate. It may result in rear end collision(s) with stationary traffic wanting to turn right with approaching traffic.

The Audit Team noted on the design drawings the proposed raised table crossing and kerbing detail. The Audit Team are concerned that the proposed ramp will commence out on the carriageway, due to required kerb and gradient standard. This may result in road users striking the ramp edge and directing them towards other vehicles resulting in a head on collision

The Audit Team observed onsite existing utility/water metre in the footpath of the proposed access. The Audit Team is concerned that the underground utility/water metre hasn't been accounted for in the design teams proposed design. This may result in the utility cover becoming at trip hazard if not flush with the pavement resulting in potential slips or trips by Vulnerable Road Users .

The Audit Team observed onsite the exiting footway width is approximately 1.6m. The Audit Team are concerned that the footpath is insufficient in width to allow vulnerable road users to pass two abreast. This may result in vulnerable road users entering the carriageway in order to pass one another. This may result in a collision between a vulnerable road user and a vehicle.

The Audit Team noted on the design drawings the visibility splay, at the proposed access. The Audit Team is concerned that the visibility splay shown are for vehicles on the pedestrian crossing, not at the STOP line. Inadequate visibility may result in vehicles entering the carriageway with oncoming vehicles, which may result in a side swipe type collision.

The Audit Team observed onsite the location of the existing warning signage. The Audit Team are concerned that the high sided vehicles will have their visibility obstructed by the signage when exiting. Inadequate visibility may result in vehicles edging out into the carriageway, which may result in a side swipe type collision with approaching vehicles.

The Audit Team observed onsite a redundant post at the back of the footpath.

The Audit Team observed onsite the overhead utility wires at the existing field access.
