Galway County Council

February 2022

**PROPOSED HOUSING DEVELOPMENT
AT BALLYMOE, COUNTY GALWAY
Stage 1 Road Safety Audit**

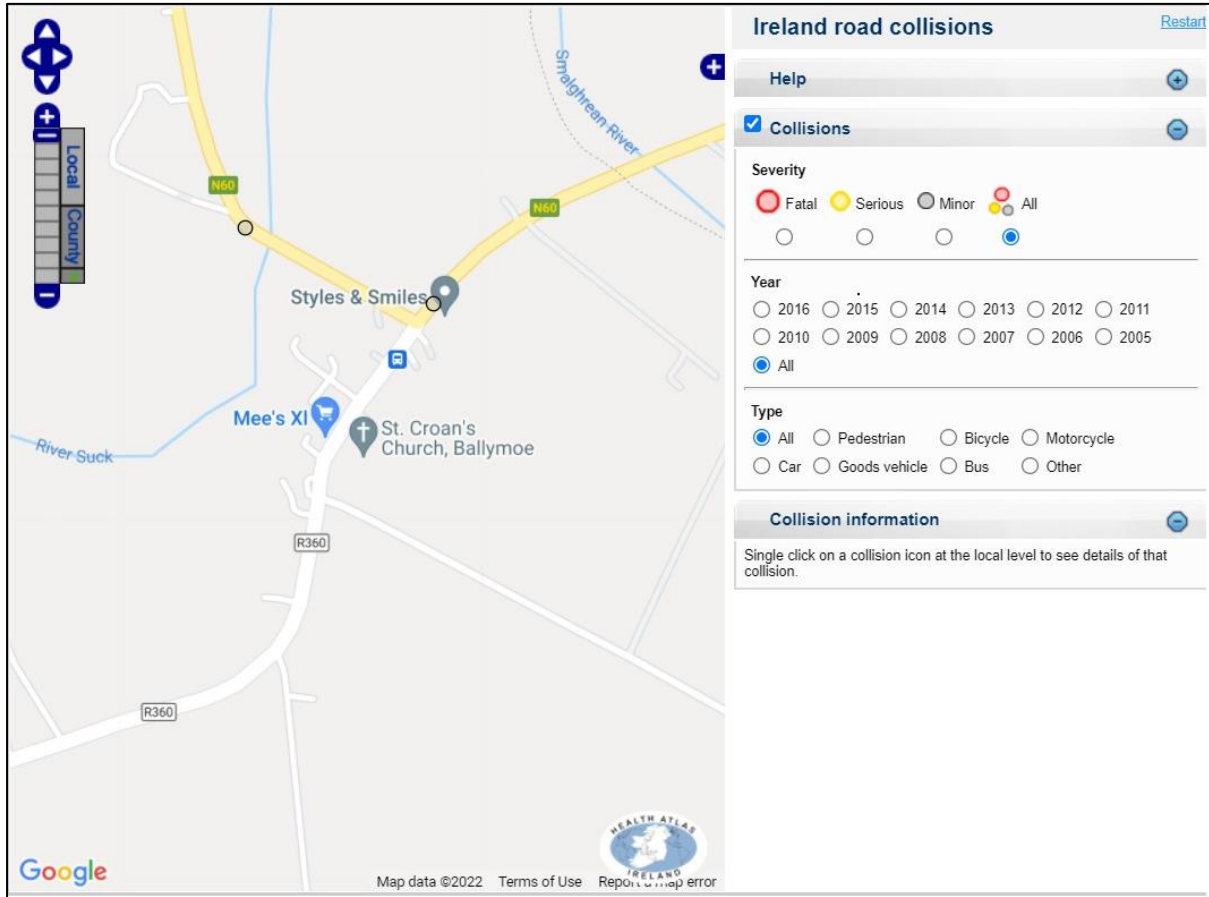
Figure 1.1: RSA Recorded Accident Collisions Data

There were no Road Safety Authority (RSA) recorded accident collisions on the existing R360 and cul-de-sac local road, in the vicinity of the proposed development site, during the available years 2005 to 2016.
