CONSERVATION REPORT FOR UPGRADE WORKS TO ORANMORE LIBRARY (FORMALLY ST. MARY'S R.C CHURCH) ORANMORE, CO. GALWAY.

ORANMORE LIBRARY, MAIN STREET, ORANMORE, CO. GALWAY H91 PC59.

PREPARED BY SCOTT TALLON WALKER ARCHITECTS, CONSERVATION ARCHITECTS GRADE 2

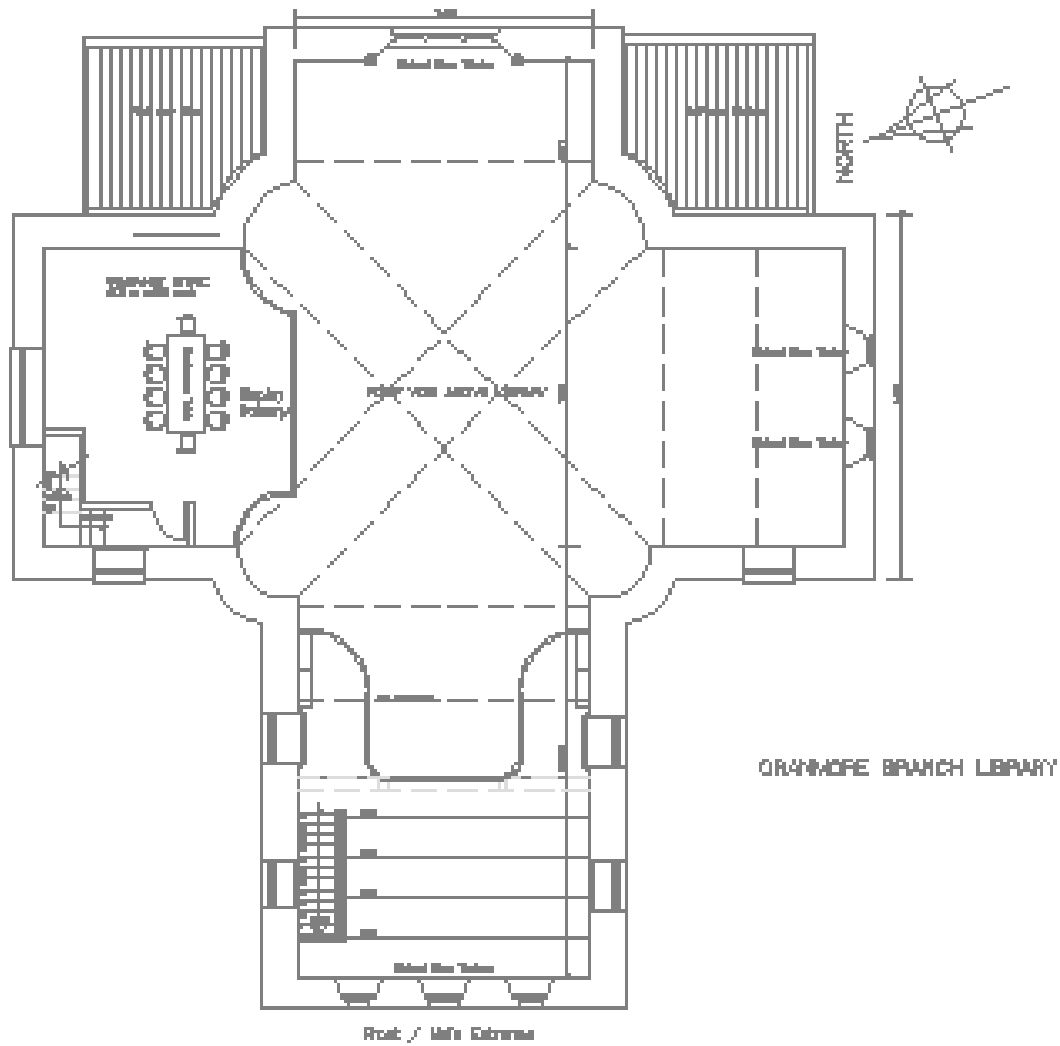
ILLUSTRATION 3. Existing Upper floor Balcony plan.

FIRST FLOOR PLAN. EXISTING LAYOUT
SCALE 1:200

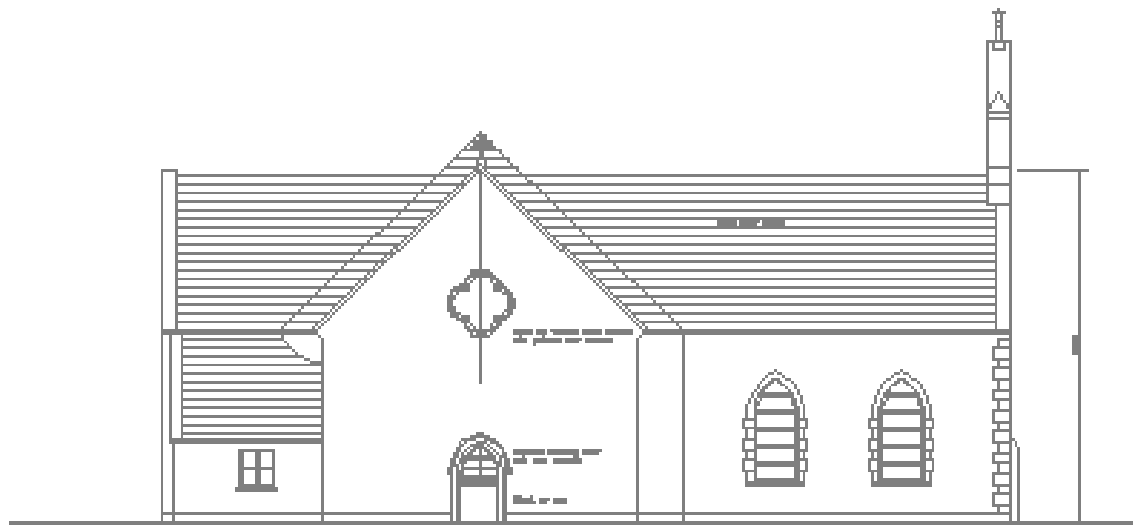
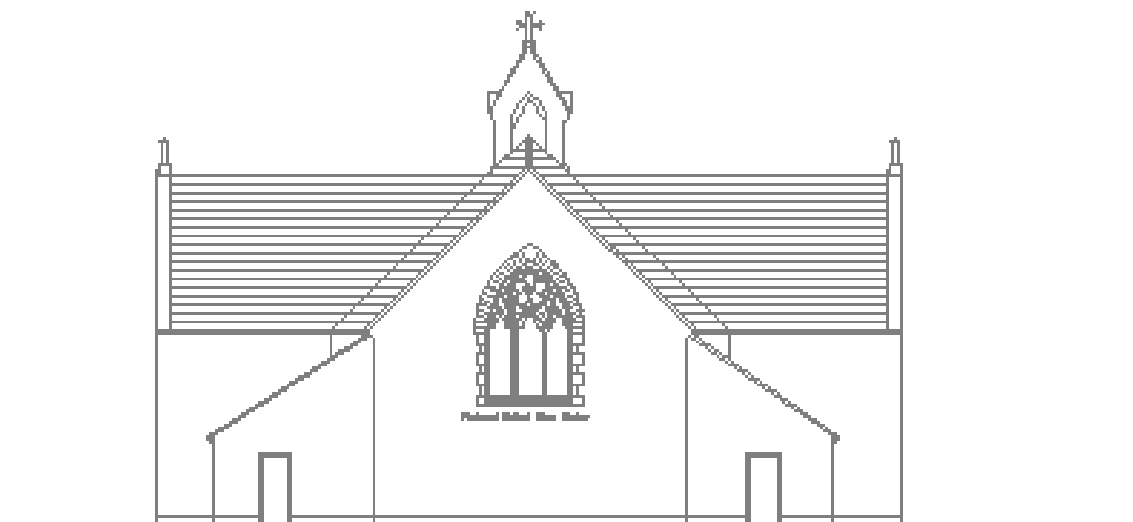
ILLUSTRATION 4. North and East Elevations.

NORTH ELEVATION
Scale 1/100

EAST (REAR) ELEVATION
Scale 1/100

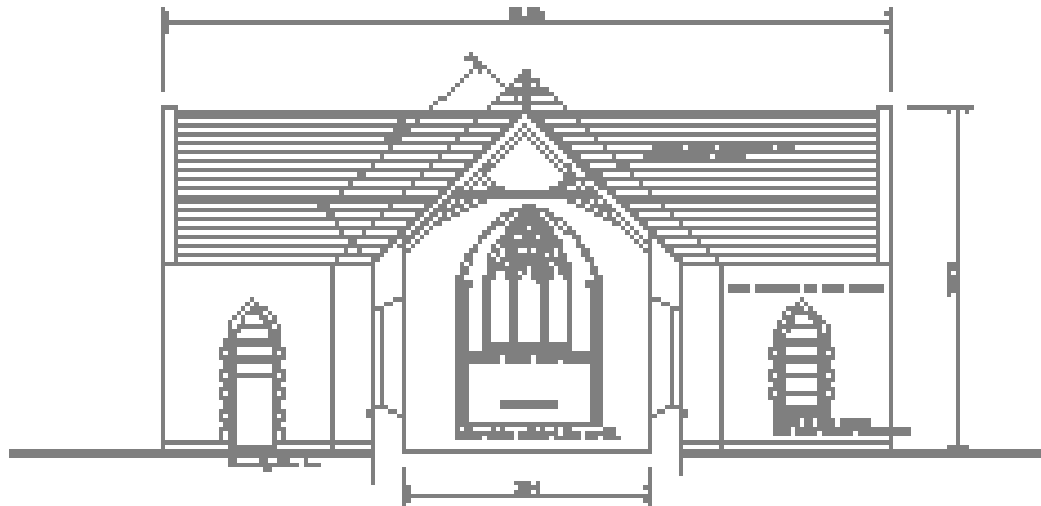
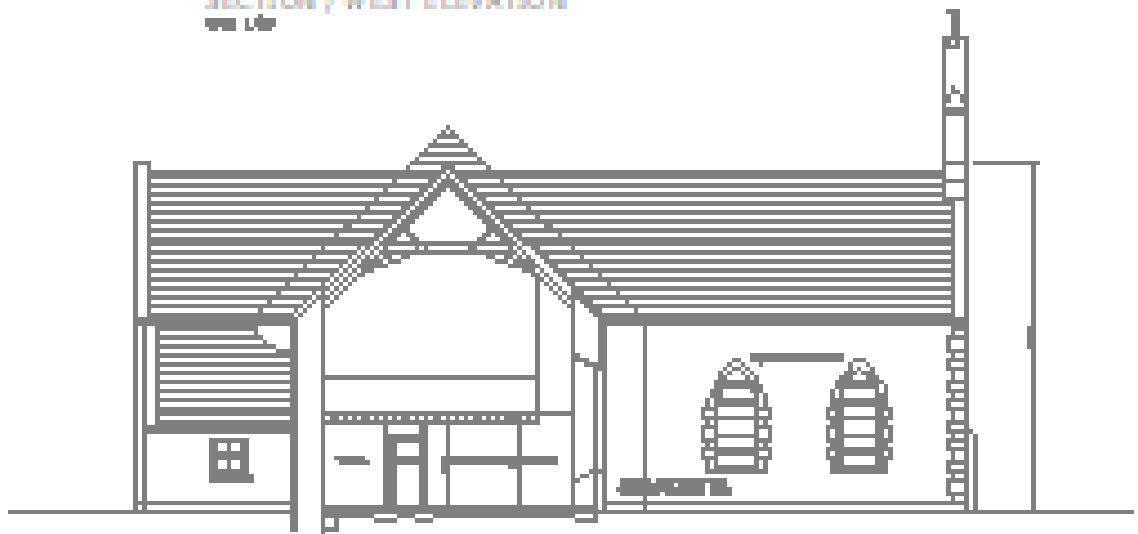
ILLUSTRATION 6. Sections.

SECTION / WEST ELEVATION
Scale 1/40

SECTION / NORTH ELEVATION
Scale 1/40

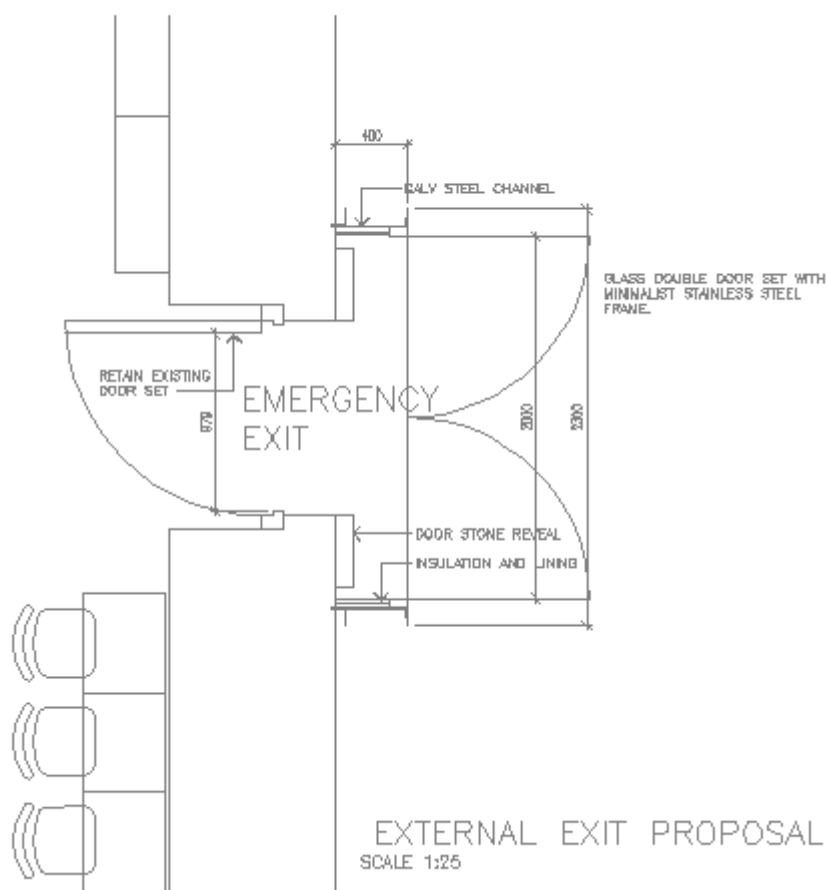
ILLUSTRATION 7 . Proposed external Lobby Plan

The library side exit door requires a minimum clear width of 850mm, and the door needs to open out. The existing door cannot be arranged for outward opening. Externally the door opening has pointed arch door openings of cut limestone hood-mouldings and chamfered limestone surrounds. It is proposed to retain the existing door and to leave it in an open position during normal opening hours. It is proposed to construct an external steel frame 400mm deep and fit glass doors into frame as final exit doors. Doors to have push bars and draft seals all around. The chamfered limestone pointed moulding around the door opening can still be viewed through glass externally. Refer to plan view of proposed external exit lobby and elevations below, illustrations 7 and 8.

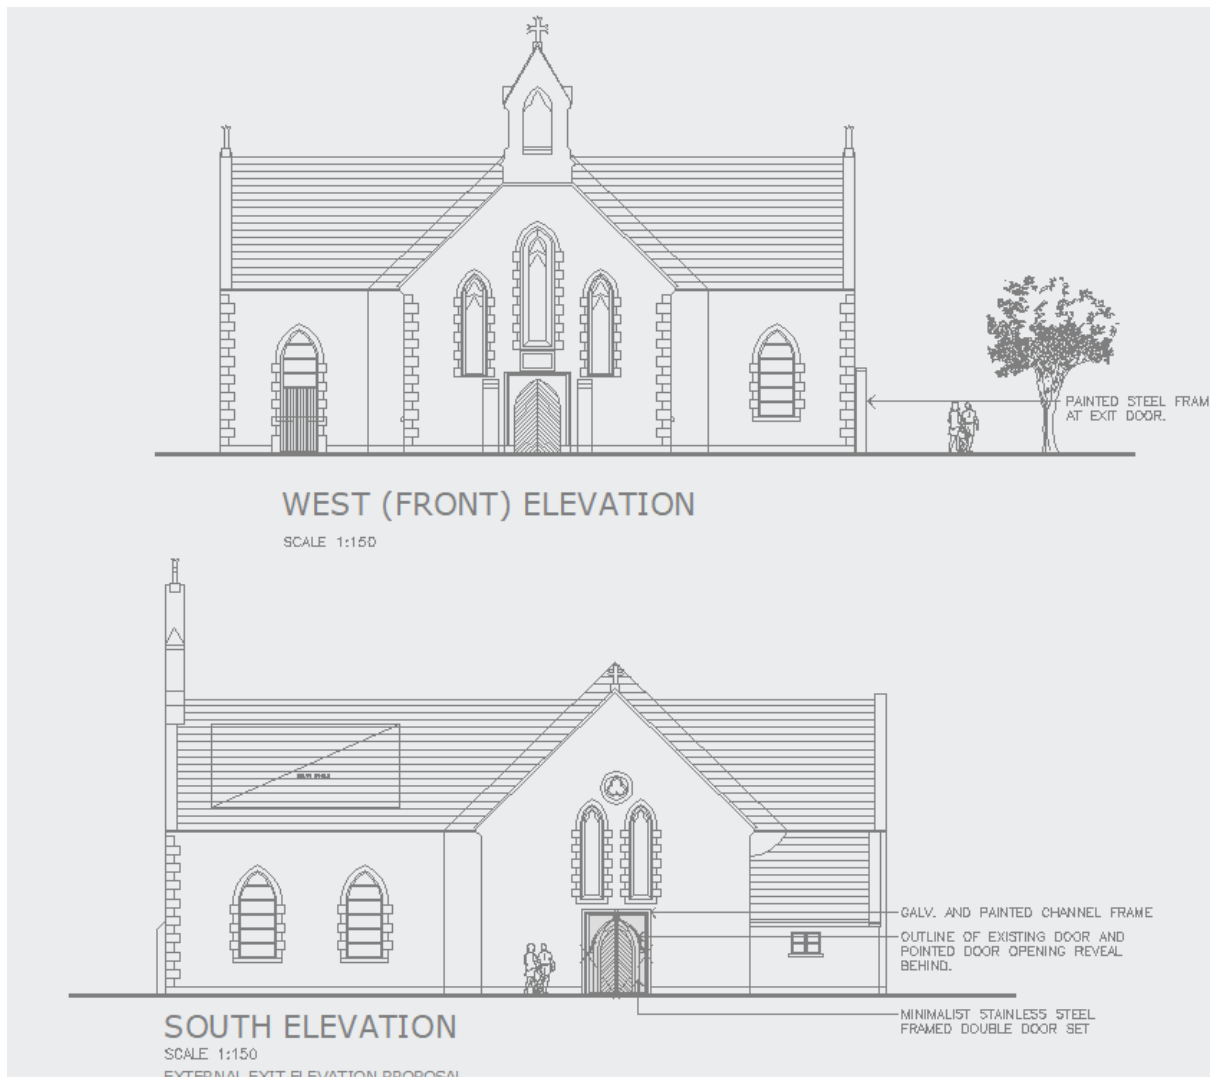
ILLUSTRATION 8 . Proposed external Lobby Elevations.

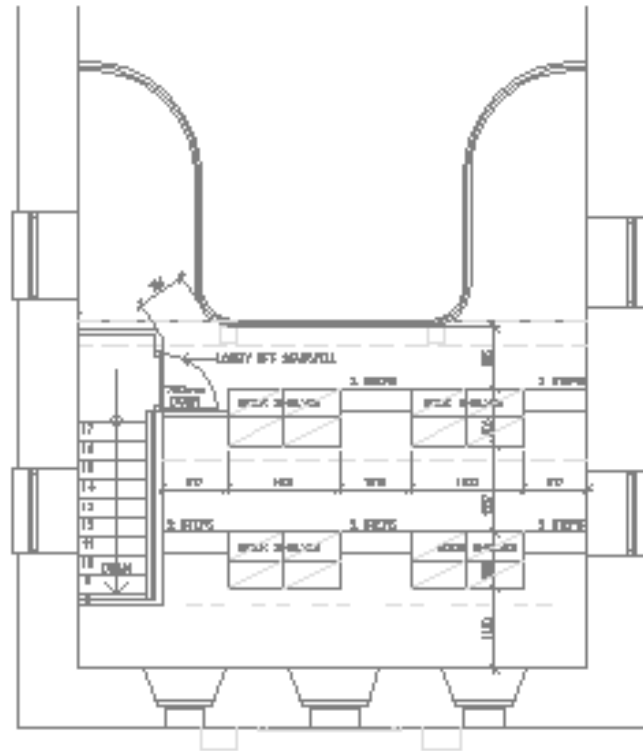
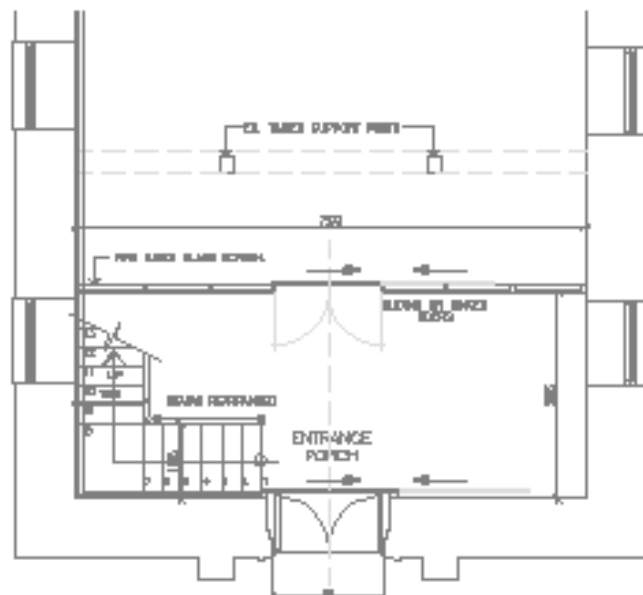
ILLUSTRATION 9. Proposed entrance lobby and balcony plans.

QUIRE BALCONY FLOOR PLAN, PROPOSED.
SCALE 1:50

GROUND FLOOR PLAN ENTRANCE LOBBY, PROPOSED.
SCALE 1:50

To facilitate 'MY OPEN LIBRARY' with Library members having access to the library from 8.00am to 10.00pm seven days a week it is proposed to construct a security porch at the main entrance within the building. The existing timber doors are to be retained in place in an open position. A glass sliding door is proposed to be fitted. This door will be programmed to open automatically while Library is manned. When Library is not manned the glass door can be opened by Library card holders. This will get them into the newly created lobby where a second door will be openable by same card for access into the library main body.

The lobby screen will be a fire rated glass screen and door. The gallery stair is to be rearranged for disabled access and will exit within the newly created lobby.

The existing gallery over main entrance is to be taken into play for use by library users. Book shelving is proposed. A stair enclosure is to be constructed as shown on drawings.

These new proposals will have no material impact on the existing balcony structure. The existing entrance lobby constructed in the nineties will be replaced with a larger lobby. The re-arranged new stair will be constructed within the footprint as the existing stair. The existing stair is not the original balcony stair and would have been fitted also in the nineties. All works being proposed is reversible.

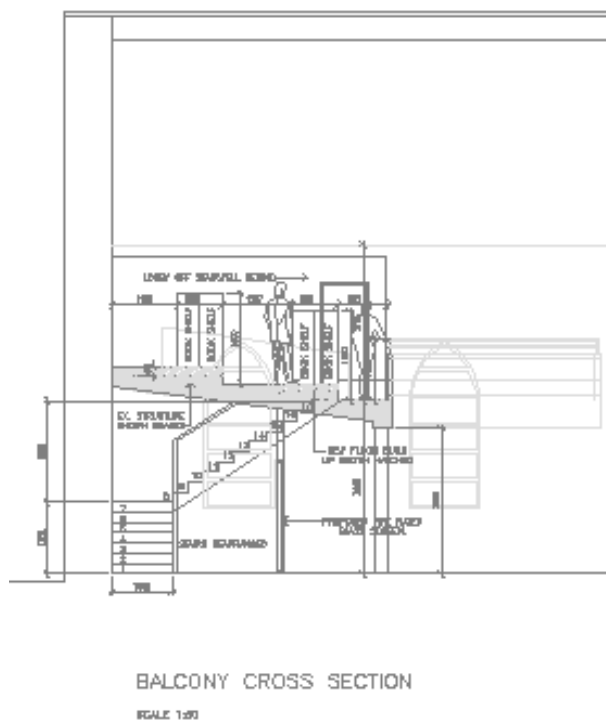
ILLUSTRATION 10. Proposed entrance balcony section.

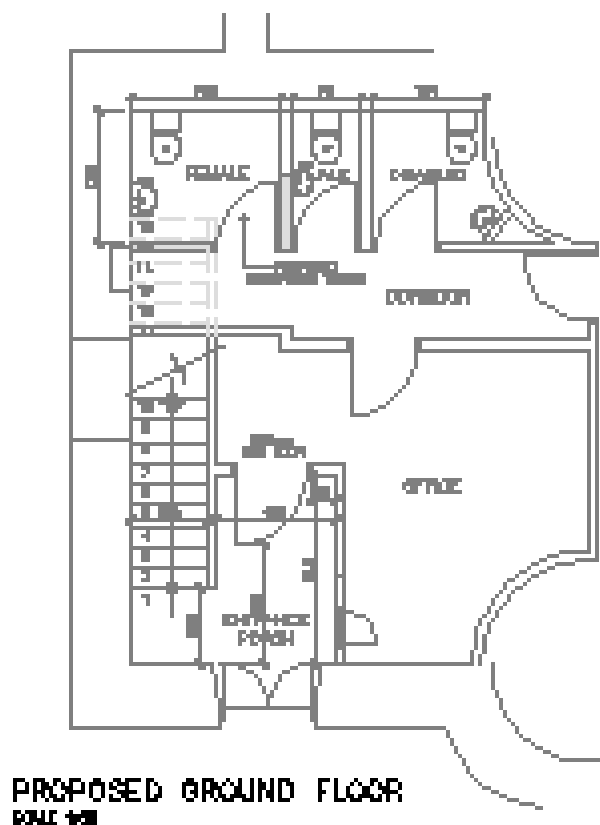
ILLUSTRATION 11. Proposed ground floor north wing rearranged stair and toilets

It is proposed to rearrange the north transept balcony stair to comply with fire regulations and disabled access. Like the main entrance balcony stair, the transept balcony stair was fitted in the nineties and is not the original balcony stair. It is proposed to fit a new stair in a straight flight with a half landing. The stair will have a fire rated enclosure. The stair exit door positioning at balcony level accommodates exiting away from open balcony balustrade. The stair will exit into a fire protected lobby at ground floor. The new stair location will require minor rearrangements of toilets under on ground floor. The proposed stair landing carries across gable end window which is not ideal. However it is located in this location so stair complies with disabled access. The depth of the wall has the window set 300 to 400mm away from the stair stringer. The stair stringer section to be made as small as possible to allow as much light into stairwell as possible.

This new proposal will have minimum impact on the existing balcony structure. The existing lobby constructed in the nineties will be replaced with a larger lobby. The existing stair is not the original balcony stair and would have been fitted also in the nineties. The toilets on ground floor were constructed in the nineties and the rearranged stair necessitates toilets rearrangement as indicated on drawings included in this report. All works proposed will not materially effect original building structure, i.e. walls window openings or door openings. All work being proposed is reversable.

3. North transept balcony stair rearrangement. To comply with fire regulations and disabled access it is proposed to replace /rearrange stair as shown on drawings included with this report. The new arrangement is a straight flight with a half landing. The new stair will exit into a protected lobby and have an enclosure at balcony level. The stair being replaced is not an original stair to the balcony. The fitting of the new stair will have minimal effect on the existing balcony structure as old and new stair are in the same location. The toilets on ground floor under stair will require rearrangement as indicated on attached drawings.

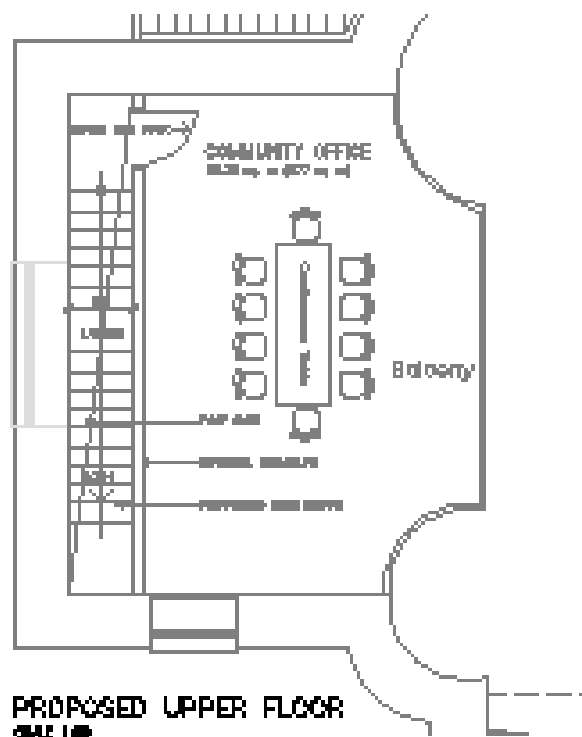
ILLUSTRATION 12. Proposed upper floor north wing rearranged stair plan.

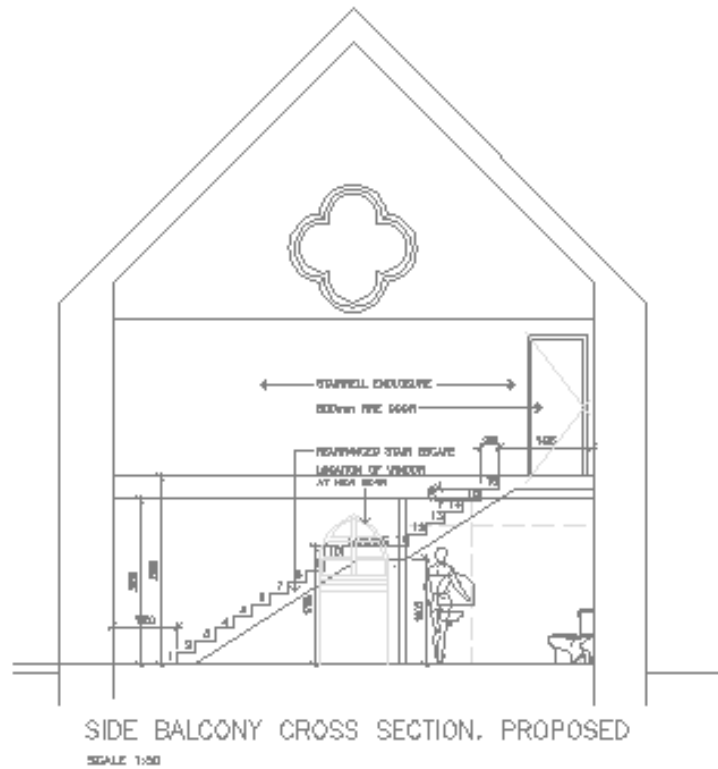
ILLUSTRATION 13. Proposed rearranged stair from balcony north wing.

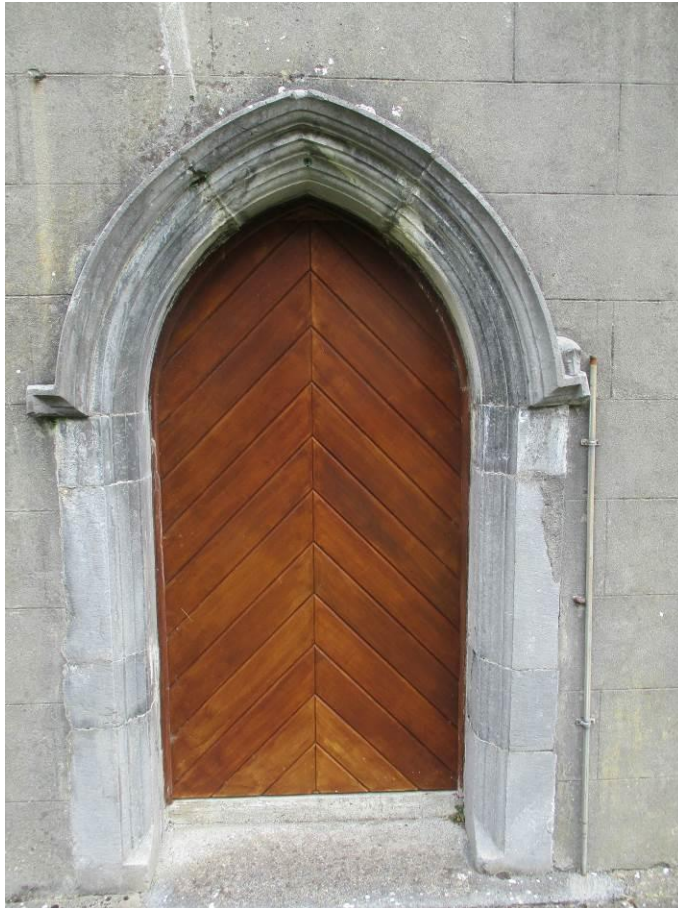
Image 6. IMG_0530. Exit door. South Elevation.

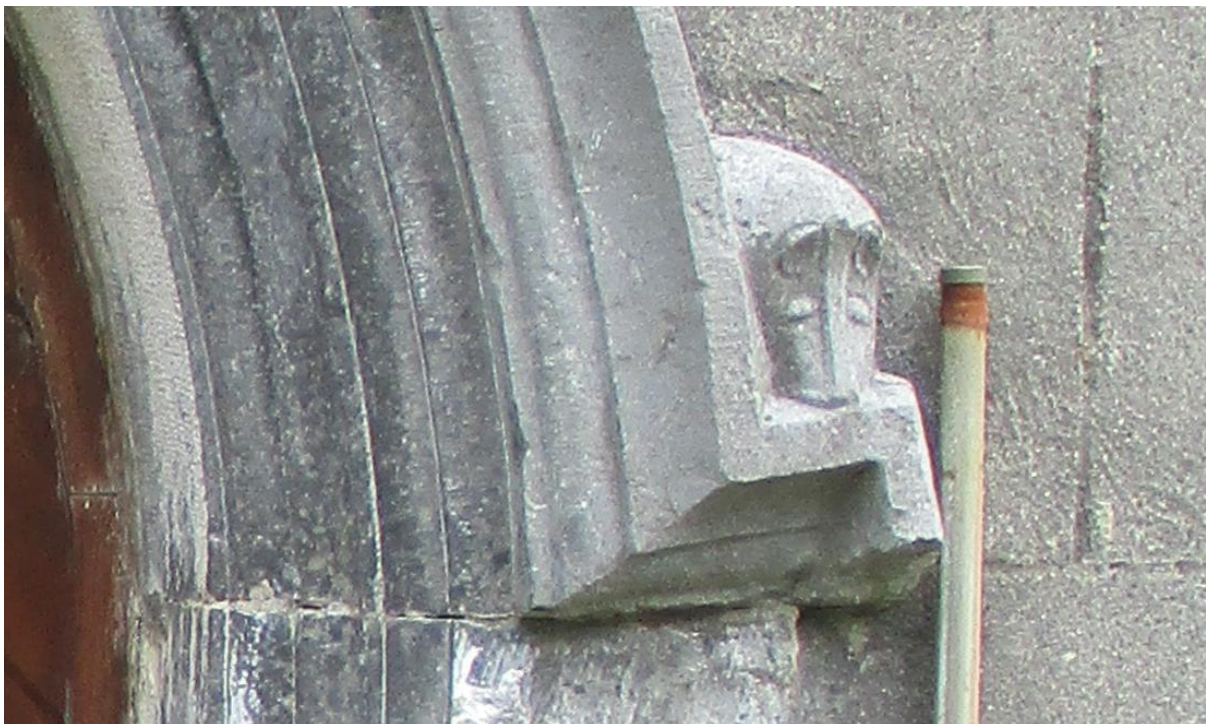
Image 7. South transept exit door reveal detail.

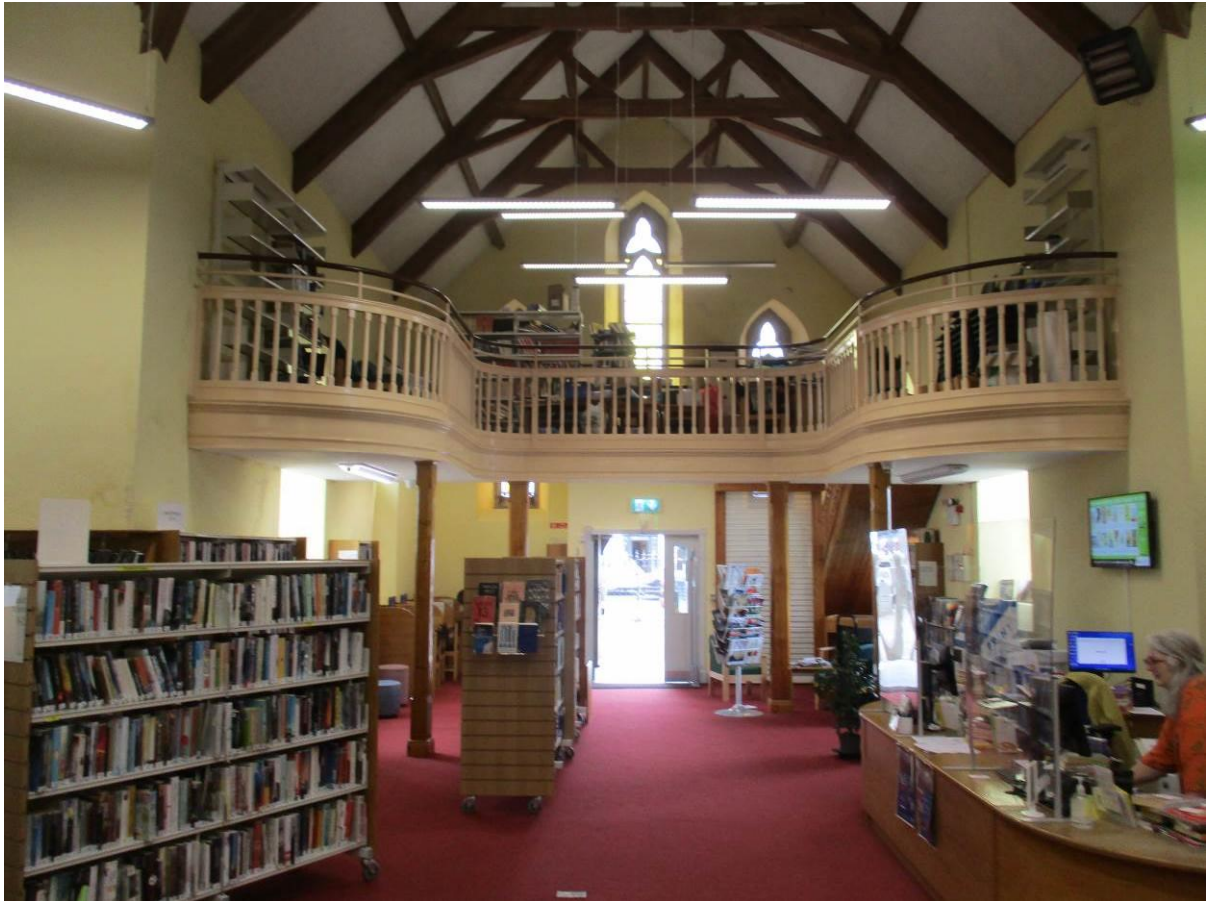
Image 8. IMG_0527. Main entrance balcony.
