**Flood Risk Assessment
Lake Amenity Enhancement Project
at Long Point, Loughrea**

**On behalf of
Helena McElmeel Architects**

September 2024

**Hydrological & Environmental
Engineering Consultants**

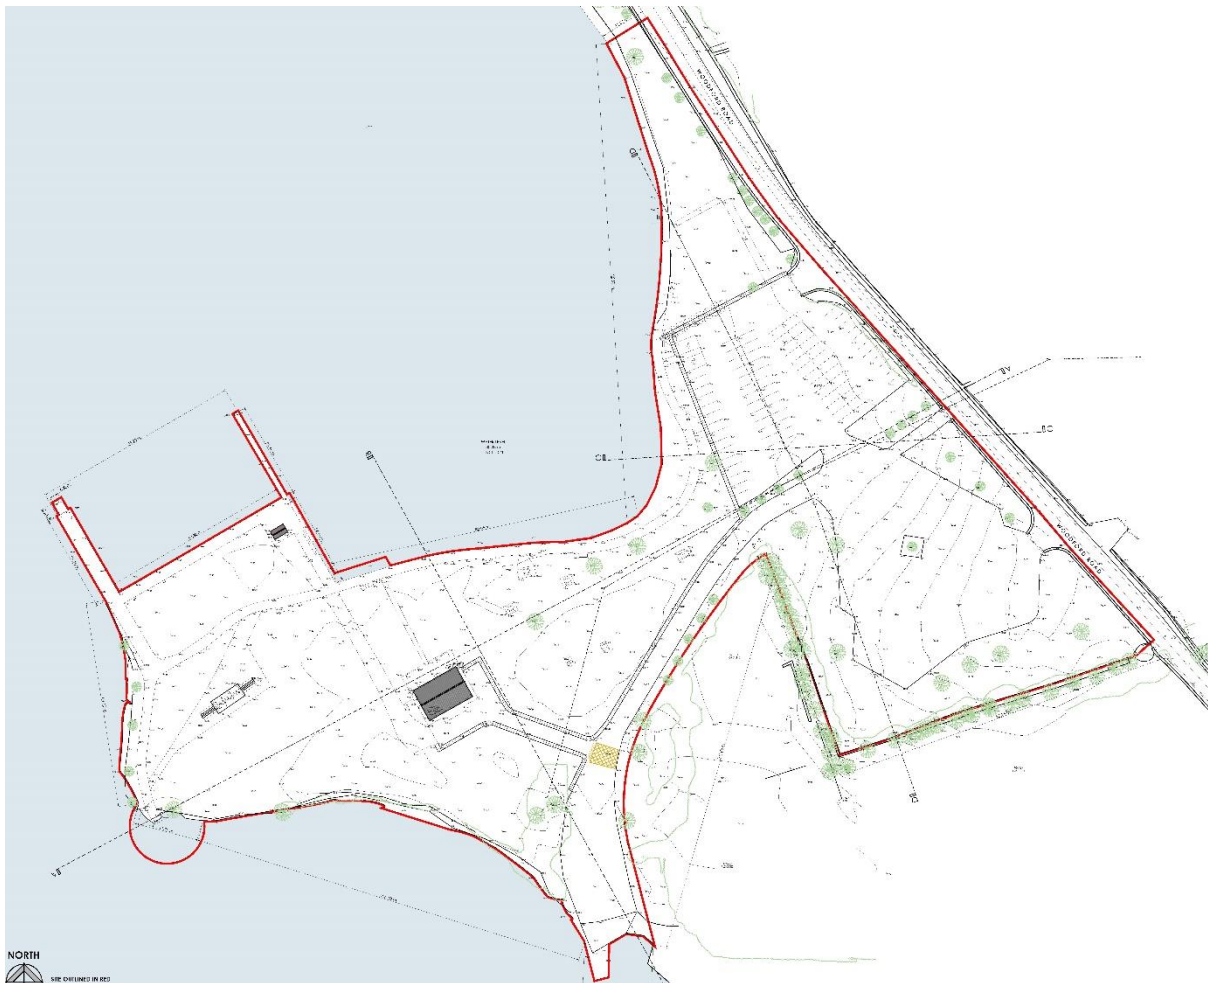
Figure 1-1 Existing Layout of facilities at Long Point including carparking and changing Facilities

Hydro Environmental Ltd was requested by Helena McElmeel Architects to carryout a Flood Risk Assessment of proposed Swimming Amenity Development at Long Point adjacent to Lough Rea, Co. Galway. Long Point has an existing quay side facilities including changing room facilities and a buoyed Swimming area on the eastern side of Lough Rea. Existing facilities including Carparking is shown in Figure 1-1.

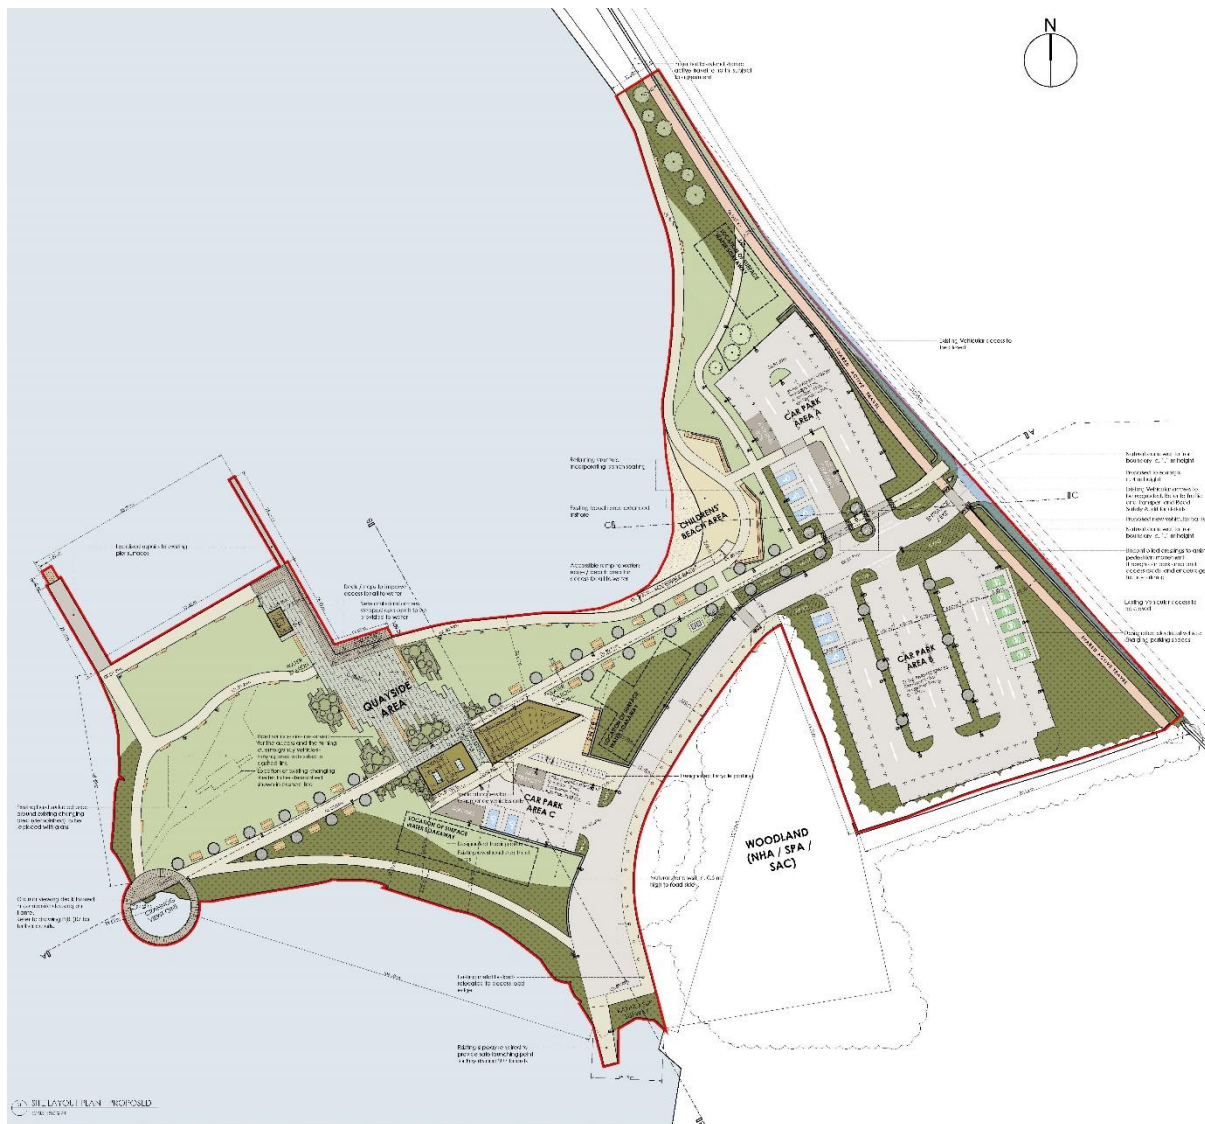
Figure 2-1 Proposed Layout Plan showing changing room facilities, carparking areas and storm water attenuation soakaway areas

This development involves the construction of a new changing rooms and storage / plant room at Long Point and extension and reconfiguration of the Car parking area on the site, refer to Figure 2-1.

The proposed Finish Floor level of the existing building will be raised to 81.15m OD and the proposed Shower building will also have a finish Floor Level of 81.15m OD to reduce potential Flood Risk to the facility.

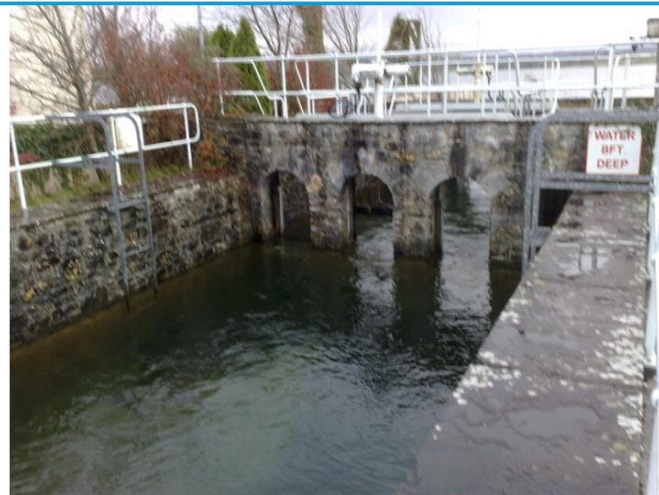
Plate 3-1 Middle Island Sluice (CFRAM Hydraulic Modelling Report 2015)

Commentary extracted from the CFRAM hydraulics modelling report concerning the Lough Rea channel outlet sluices at Middle Island and Bush Island.

It is believed that these gates are not actively managed therefore these have been modelled as surveyed in an open position.

Looking downstream at upstream face of structure.

There are two river outlet channels from the lake which are controlled by sluice gates, refer to Figure 3-2 and Plates 3-1 to 3-2. It is understood that at times of flood indicated by high levels in Lough Rea the sluice gates operated by Galway Co. Co. are fully open. The CFRAM study established a stage discharge relationship for flood events for the sluiced outlet channels assuming sluices gates are fully opened. This is presented below in Figure 3-3.

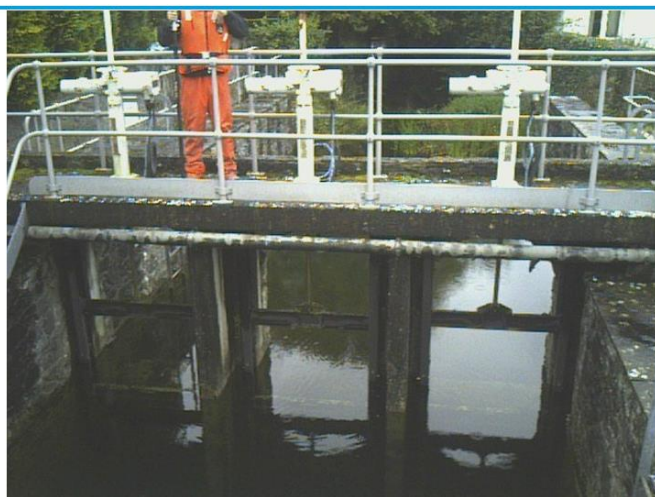
Plate 3-2 Bush Island Sluice (CFRAM Hydraulic Modelling Report 2015)

It is believed that the gates are not actively managed and therefore have been modelled as surveyed, in an open position.

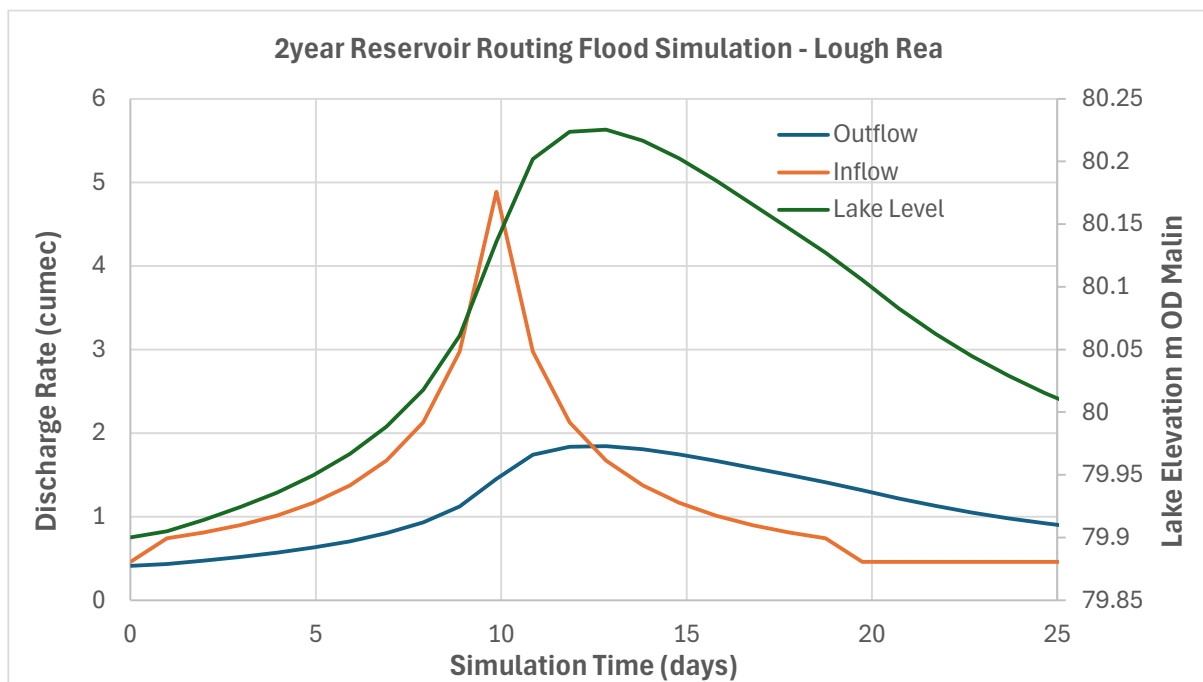
Figure 3-5 Computed Flood Hydrograph for 2year event

It is clear given the size of the lake at 3km² relative to the overall catchment of 12.5km² that attenuation storage plays an important role on the lake level and the associated outflow rates. In order to assess this correctly medium to long duration rainfall events were routed through the contributing catchment and lake levels simulated using Reservoir routing. A series of Rainfall durations were investigated with the critical duration for maximum flood levels

occurring at 450hours (12.5days) identified. The Median Flood, 100year flood and 1000year flood events were simulated. Given the long duration the percentage runoff from the contributing catchment was set at 100% and the initial conditions was set at the mean lake level of 79.9. The computed hydrographs are presented in Figure 3-5 to Figure 3-7 for the median Flood, 100year and 1000year respectively.

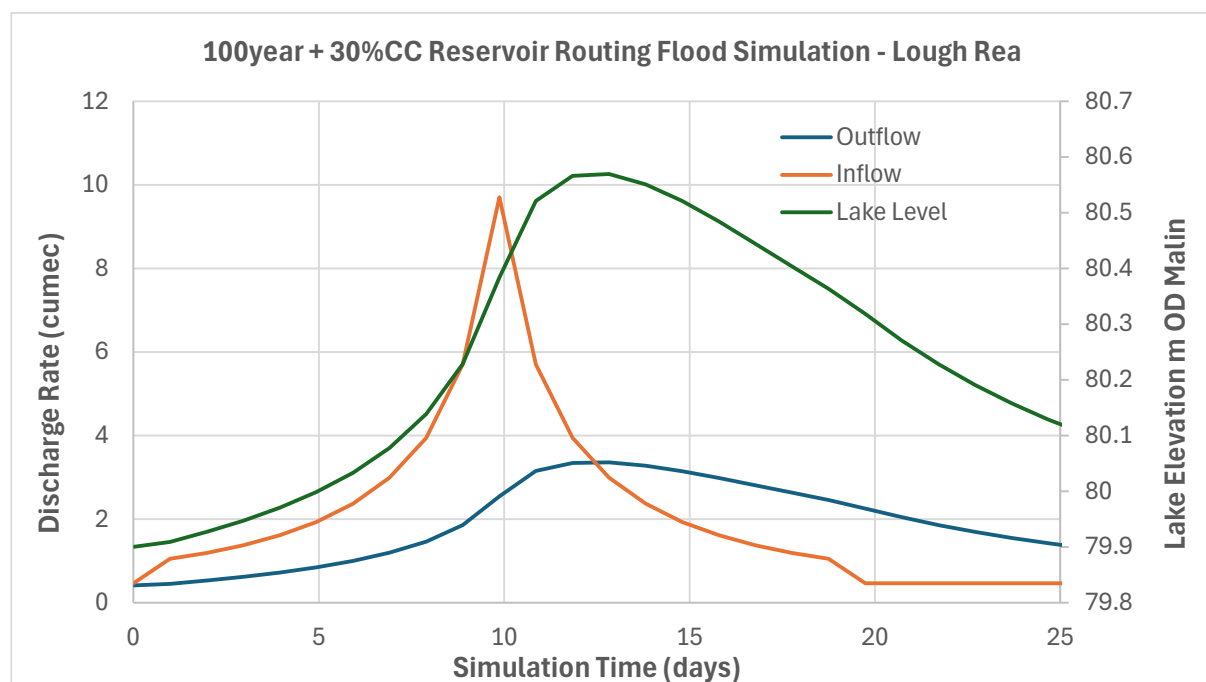
Figure 3-8 *Computed Flood Hydrograph for 100year plus 30% Climate change allowance Design Flood*

The design flood represented by the future 100year (inclusion of 30% allowance in rainfall) is presented in Figure 3-8.

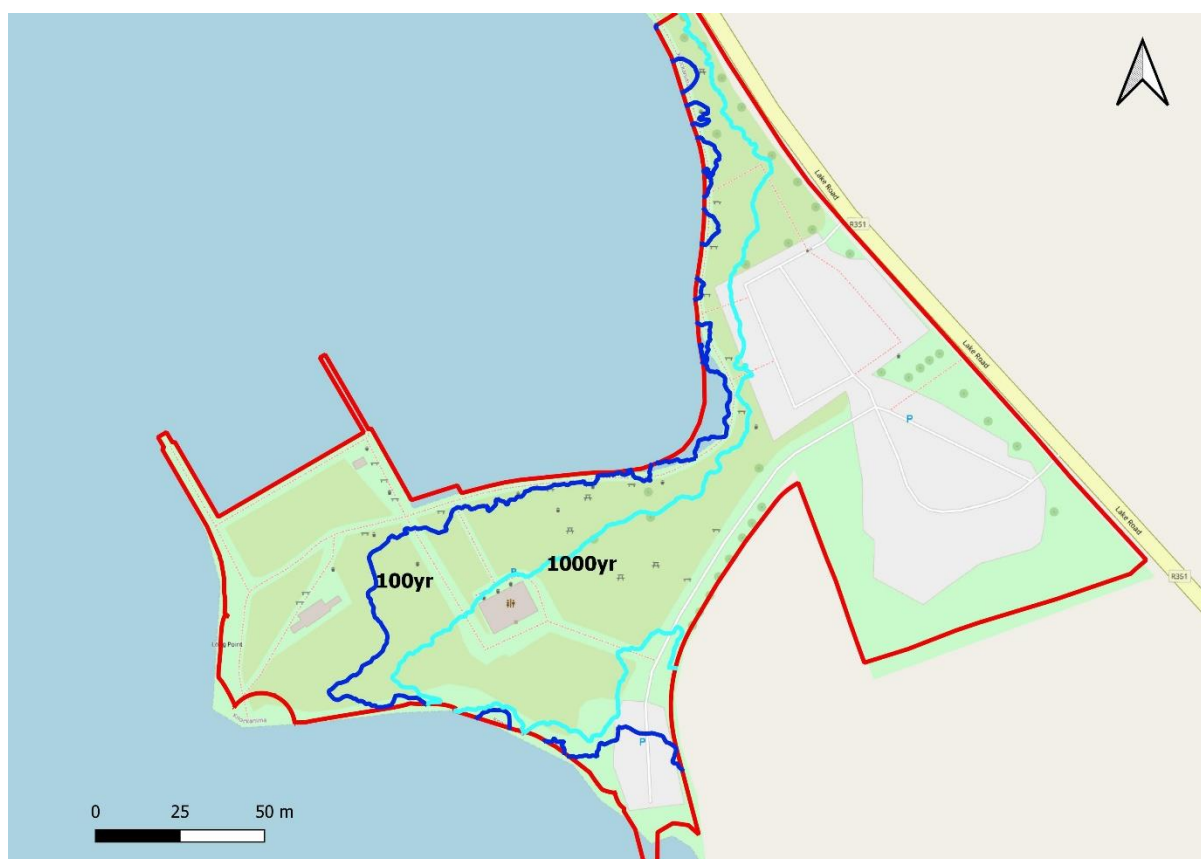
Figure 4-1 Flood Risk mapping showing present day 100year and 1000year flood contours at Long Point

The Flood Risk Map showing the current 100year and 1000year fluvial flood levels for the subject site is presented in Figure 4-1.

The development type is suited for Flood Zones A and B and all areas on the site below the 80.92 m level are at risk of flooding from the lake still water flood level plus surface wind waves. The changing rooms and plant room should be protected against the design flood level of 81.1m OD Malin plus a freeboard allowance of 0.3m (81.4m OD) in respect to potential flood damage making the development sustainable well into the future.
