**BAT AND SWIFT SURVEYS AT DUNLO HILL
TERRACE, DOOLEY'S PUB AND ADJOINING
PROPERTY, BALLINASLOE, CO. GALWAY**

Structure: Dunlo Hill Terrace, Dooley's Pub + Adjoining 3 storey house

Proposed Works: Renovation to residential units

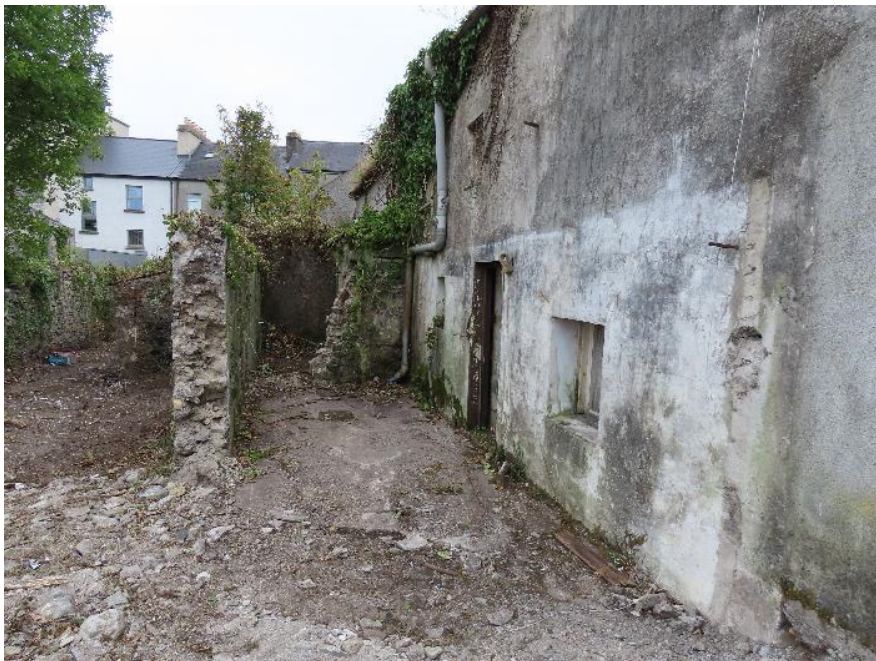
Photo 17 - Rear of Property 6 and 7 on Dunlo Hill Terrace

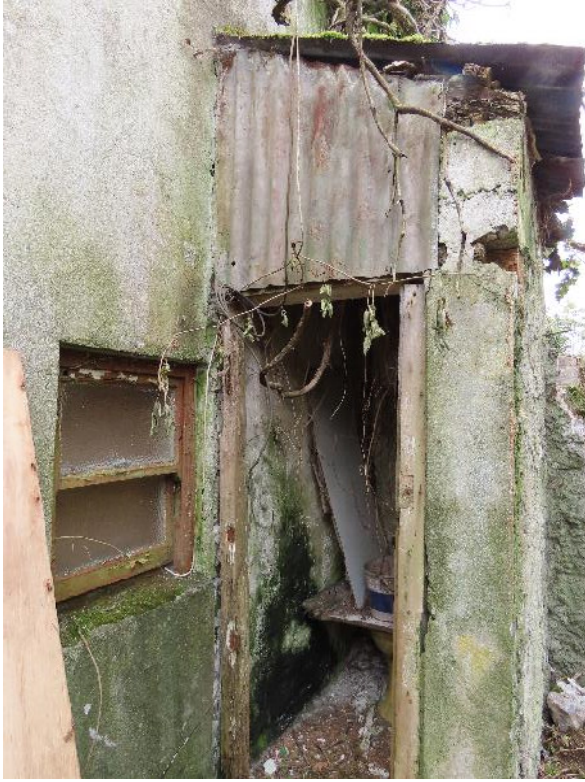
Photo 39 - Outdoor toilet outside property 6

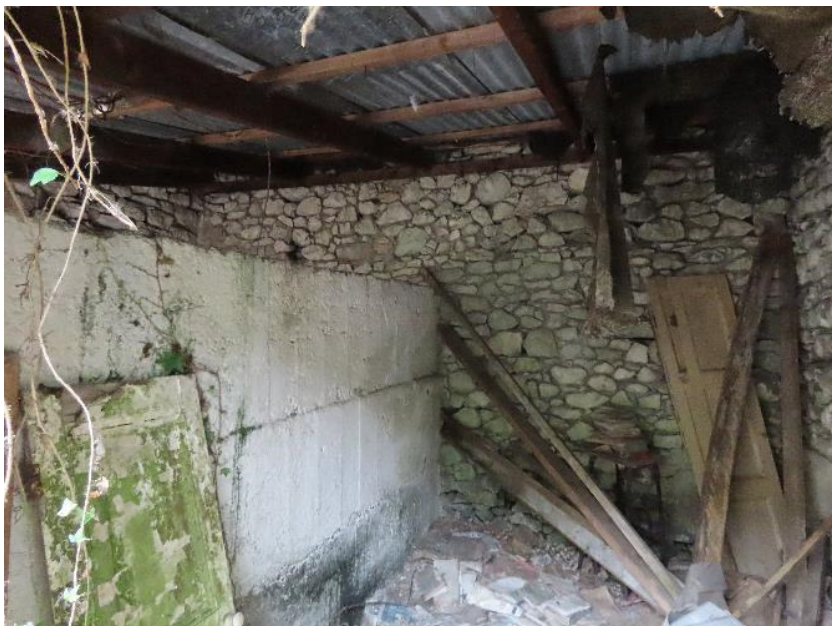
Photo 43 – stone shed to rear of Dooley’s pub

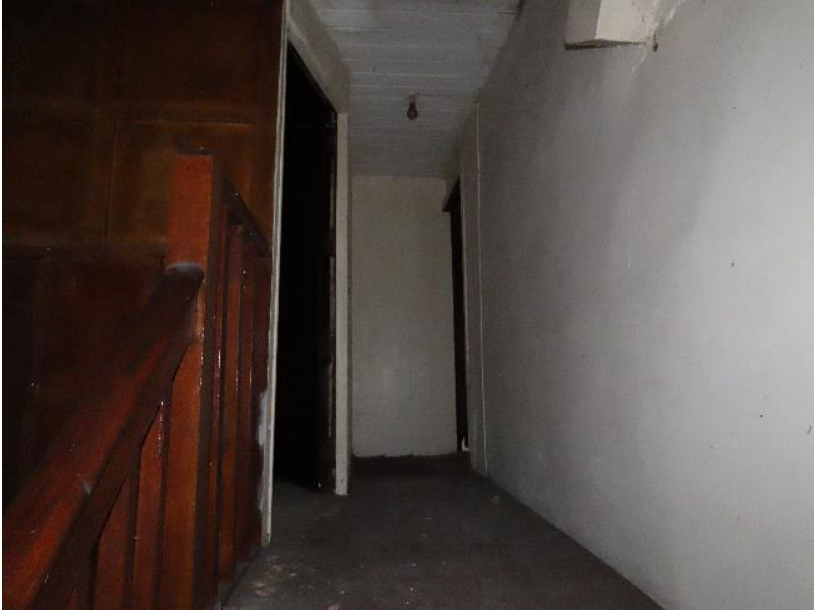
Photo 51 – attic rooms in P. Dooley’s

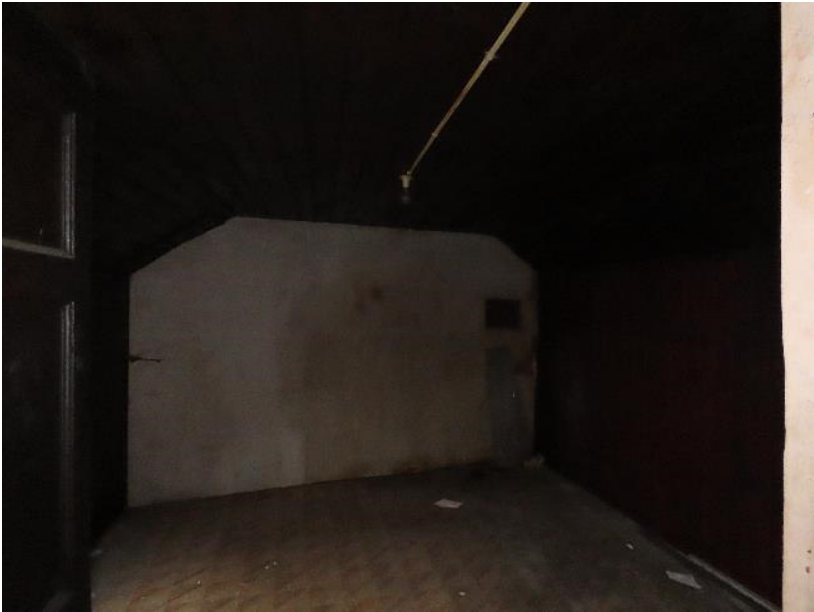
Photo 52 – attic rooms in P. Dooley’s

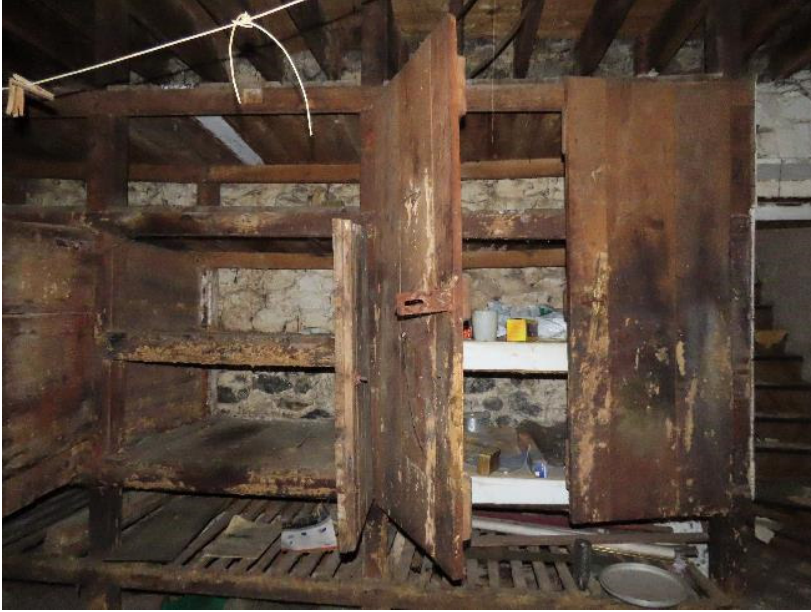
Photo 53 – basement in P.Dooley's

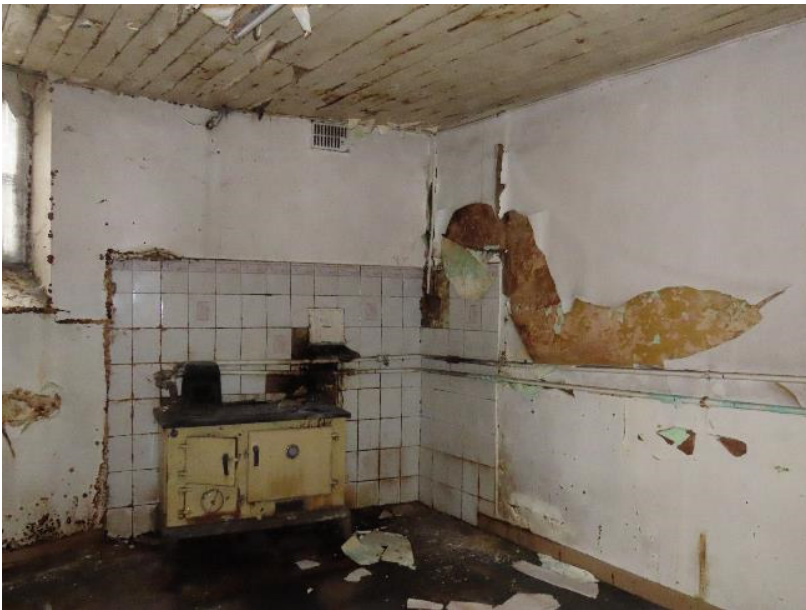
Photo 54 – basement kitchen in P.Dooley's

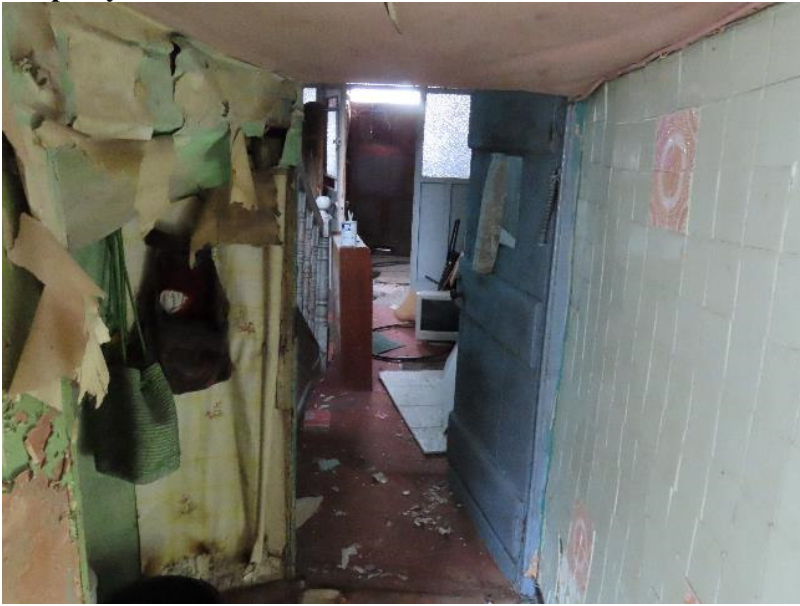
Photo 55 – hallway of Property 9

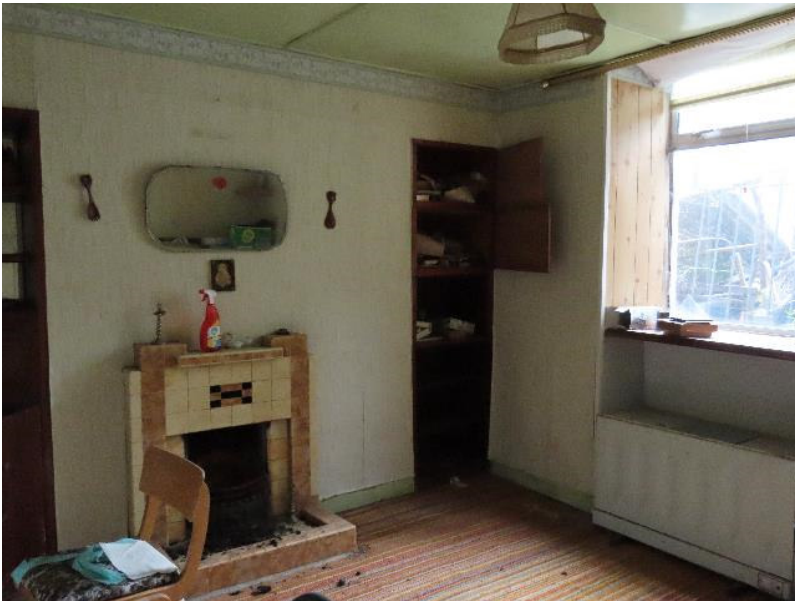
Photo 56 – downstairs room

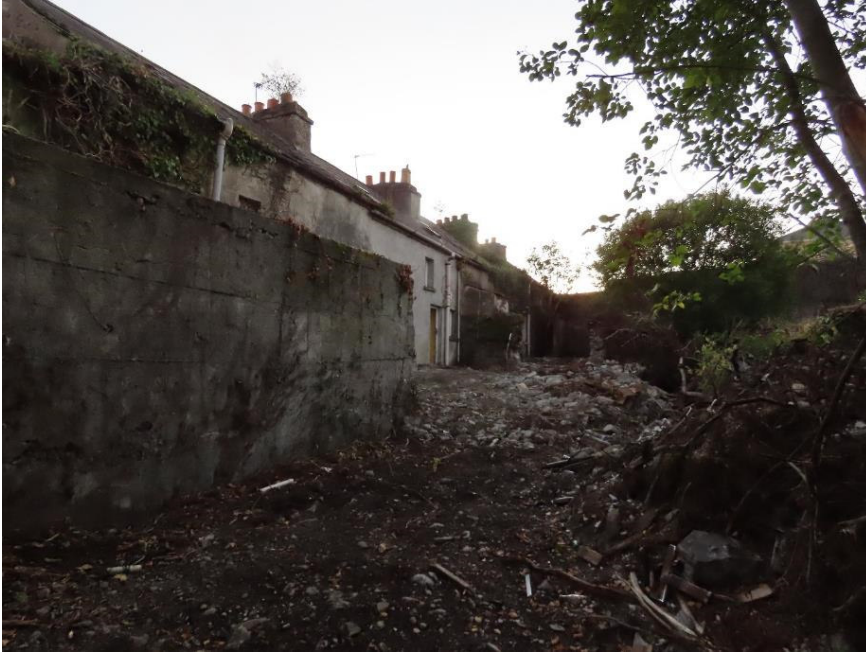
Photo 69 – dawn survey conducted to rear of terrace on Dunlo Hill

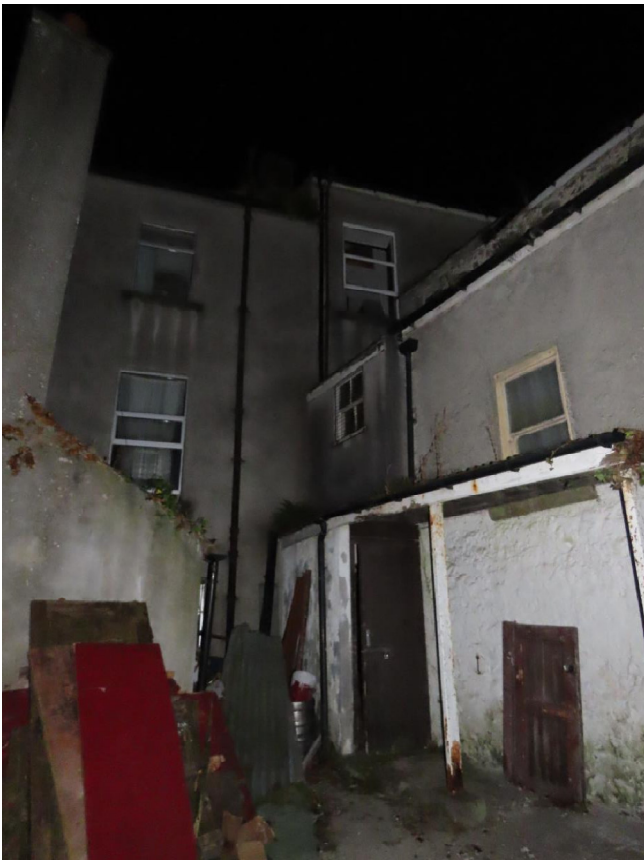
Photo 70 – dusk survey conducted to rear of Dooley's pub
