# **BAT AND SWIFT SURVEYS AT DUNLO HILL TERRACE, DOOLEY'S PUB AND ADJOINING PROPERTY, BALLINASLOE, CO. GALWAY**

## **Report Prepared for**

OBFA Architects,  
1 Johnson Place,  
Dublin 2

**October 2022**

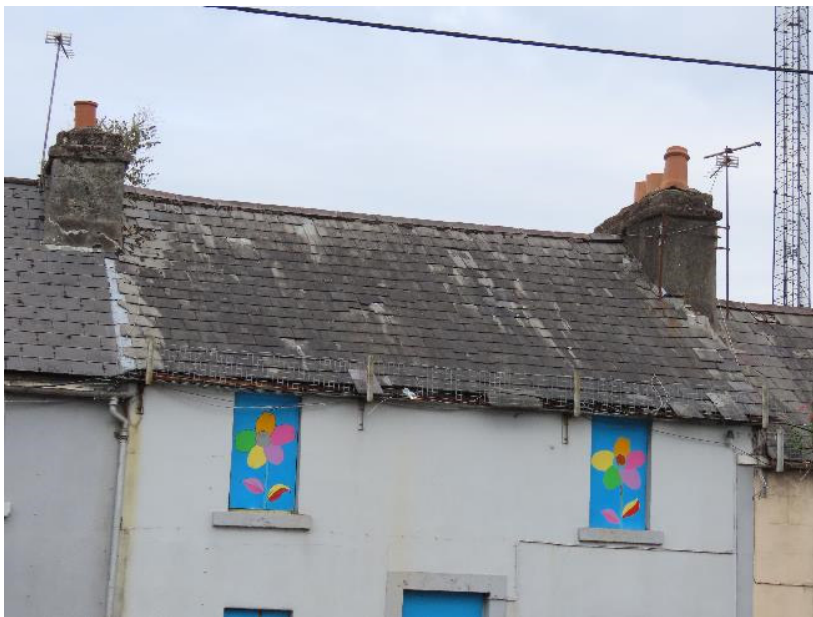
**Photo 4** - Property 4 – showing poor condition of roof. Wire slate guard in place to catch falling slates

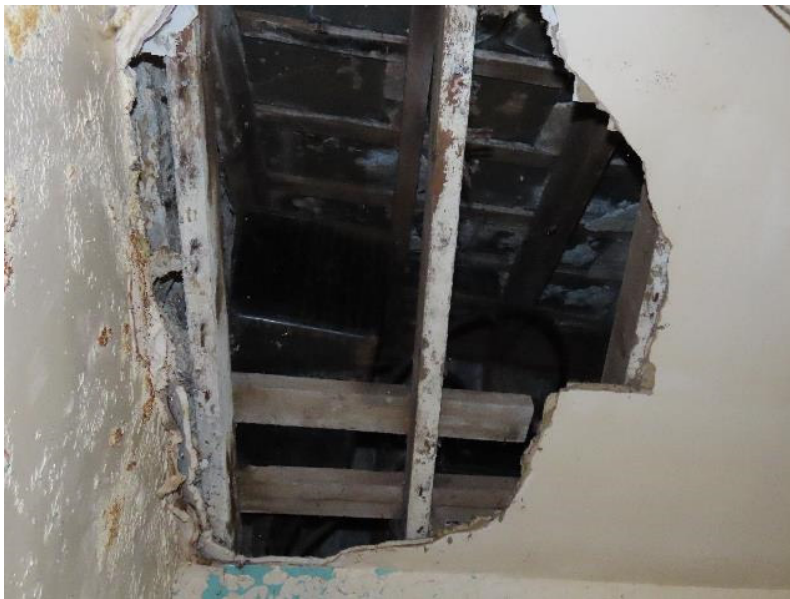
**Photo 21** - Hole in upstairs ceiling of Property 1 in Dunlo Terrace

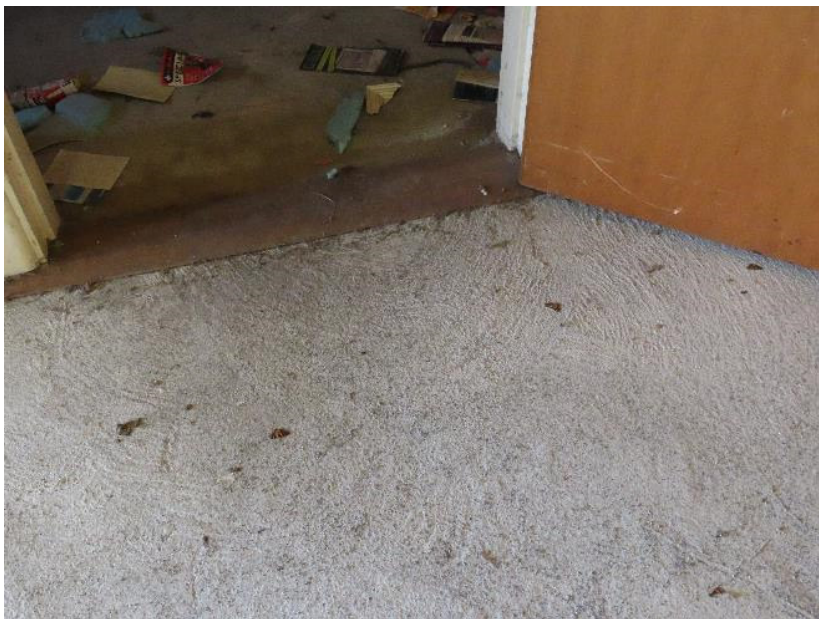
**Photo 29** - Floor of Property 3 with some butterfly wings and a few droppings of Brown long-eared bat. Used as a feeding perch by a single bat

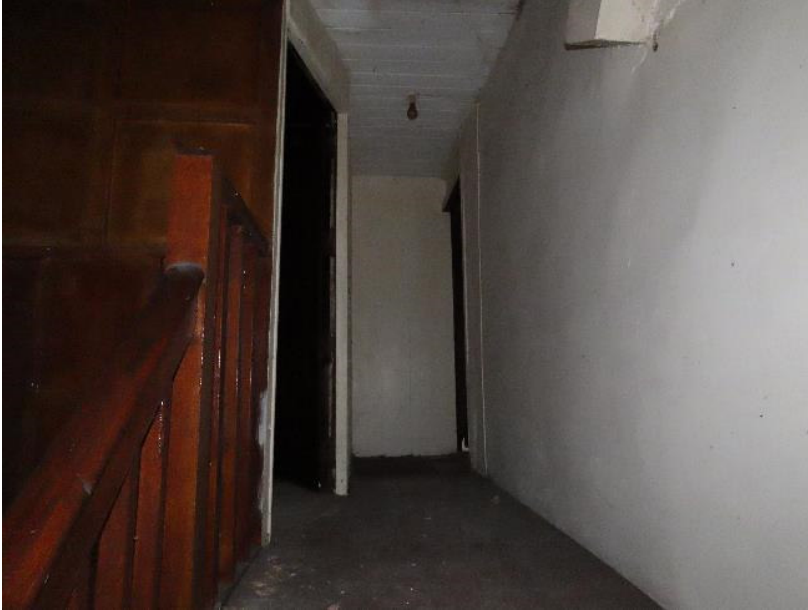
**Photo 51** – attic rooms in P. Dooley's

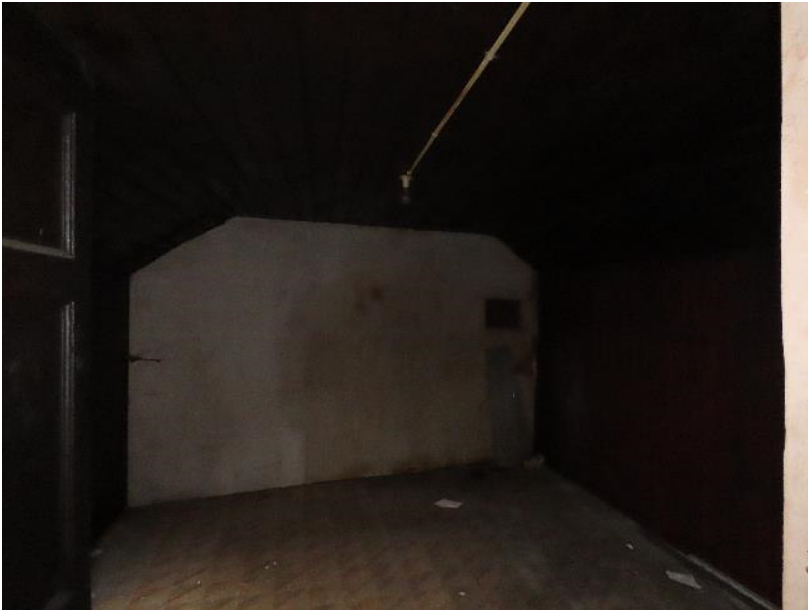
**Photo 52** – attic rooms in P. Dooley's

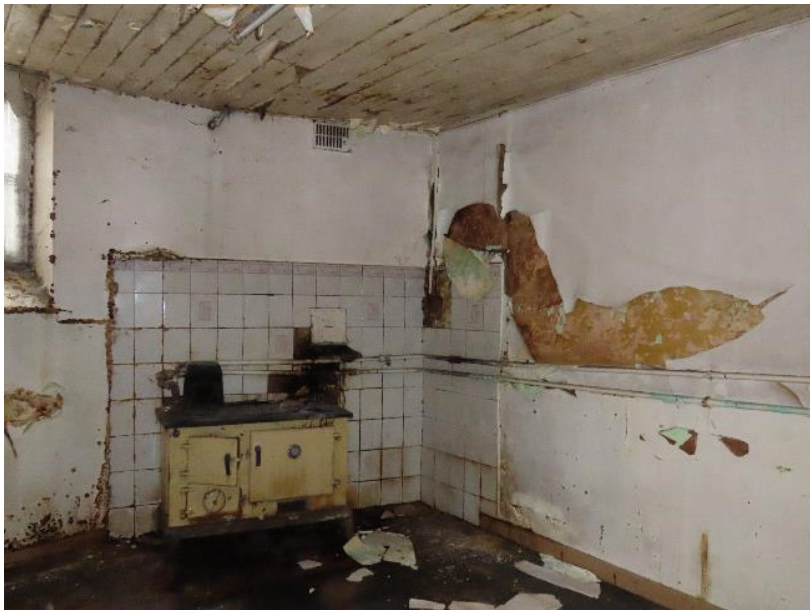
**Photo 54** – basement kitchen in P.Dooley's

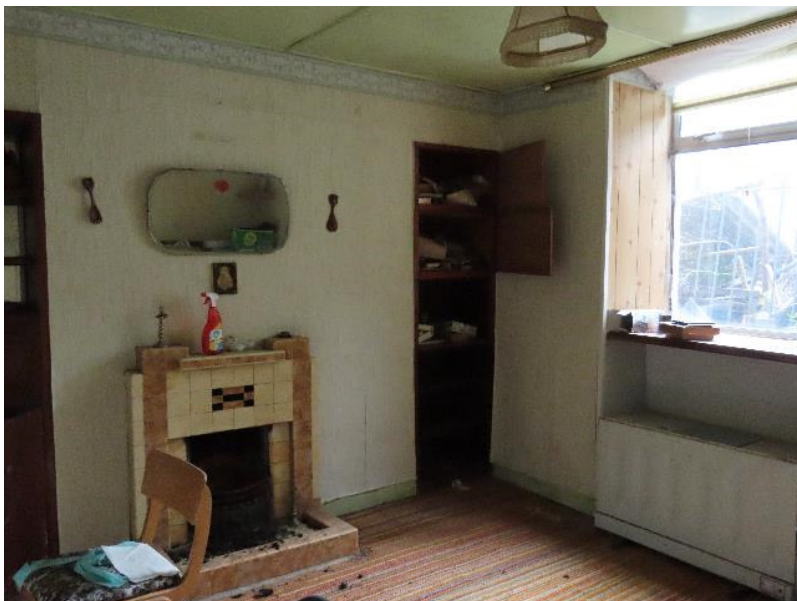
**Photo 56 – downstairs room**

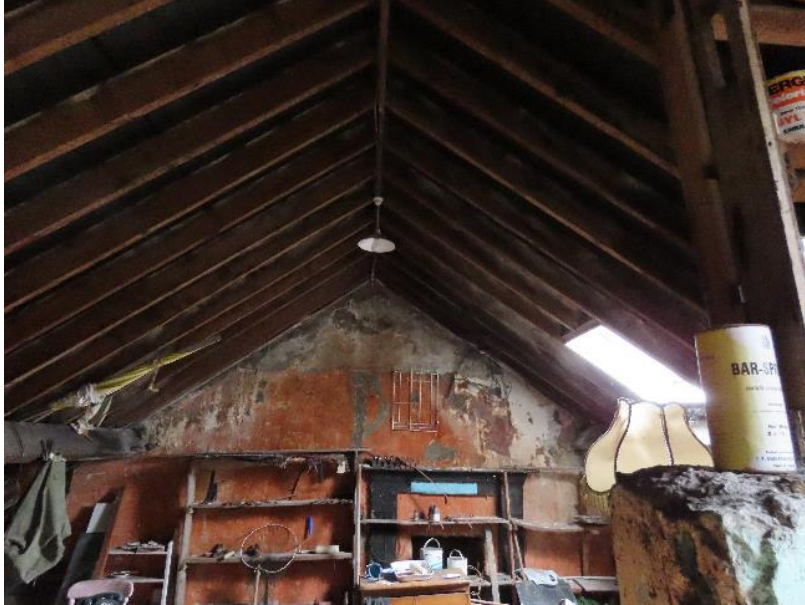
**Photo 59** – attic space being used as work space/ storage space

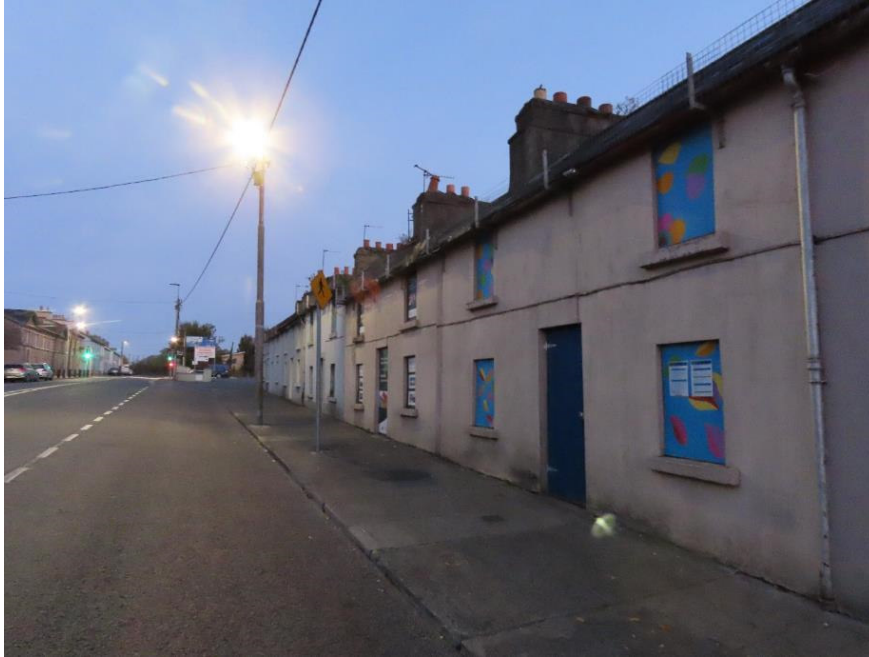
**Photo 65** – dusk bat detector survey conducted to front of terrace on Dunlo Hill

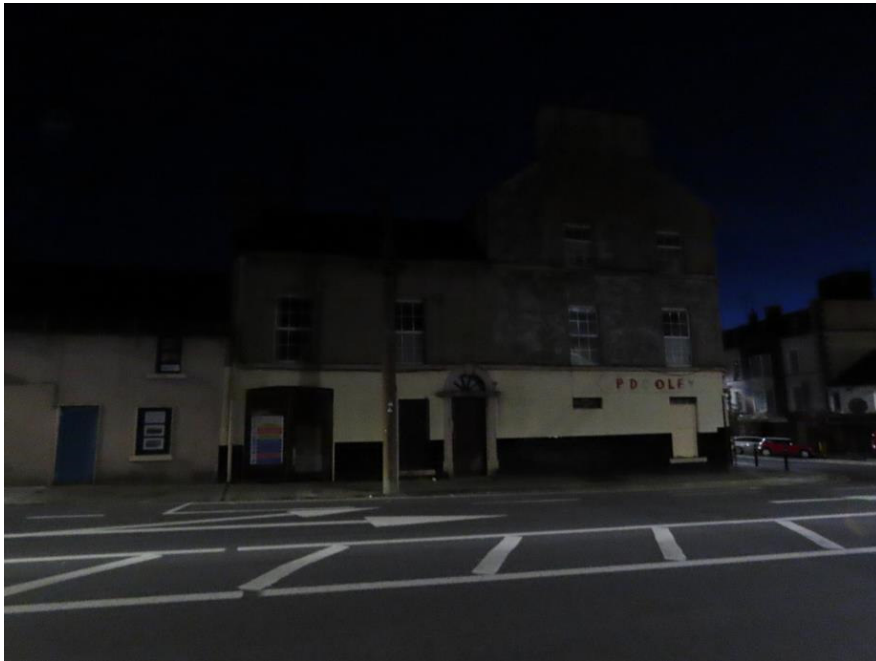
**Photo 66** – dusk bat detector survey conducted to south and east of Dooley's pub and adjoining building

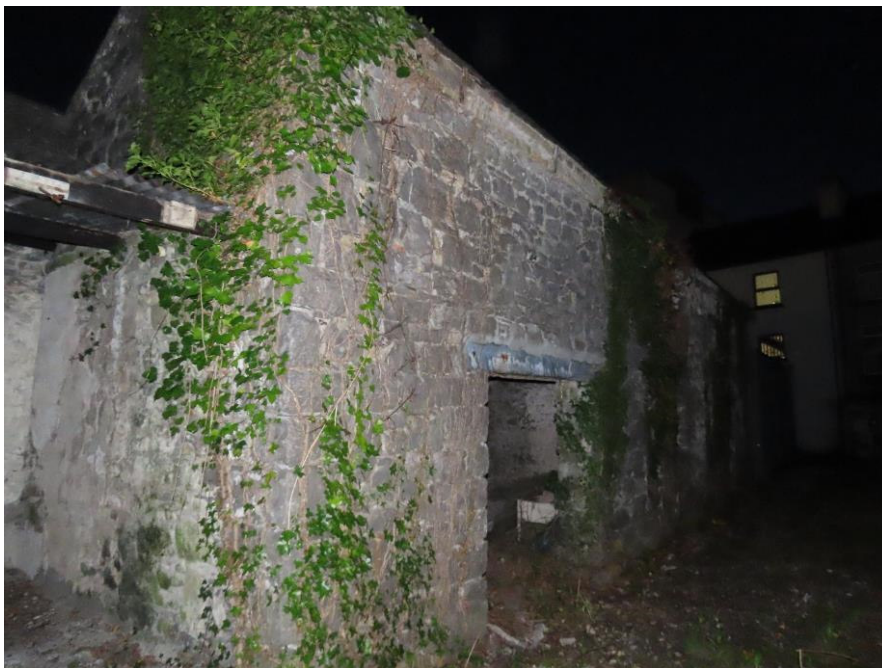
**Photo 67** – dusk survey conducted at stone outbuildings to rear of Property 9

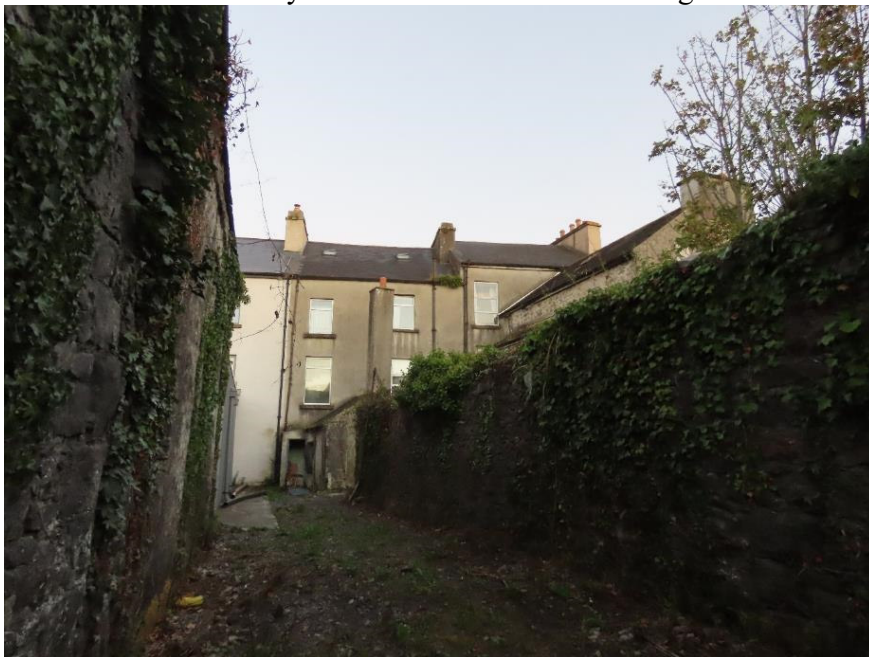
**Photo 68** – dawn survey conducted at stone outbuildings to rear of Dooley's and Property 9

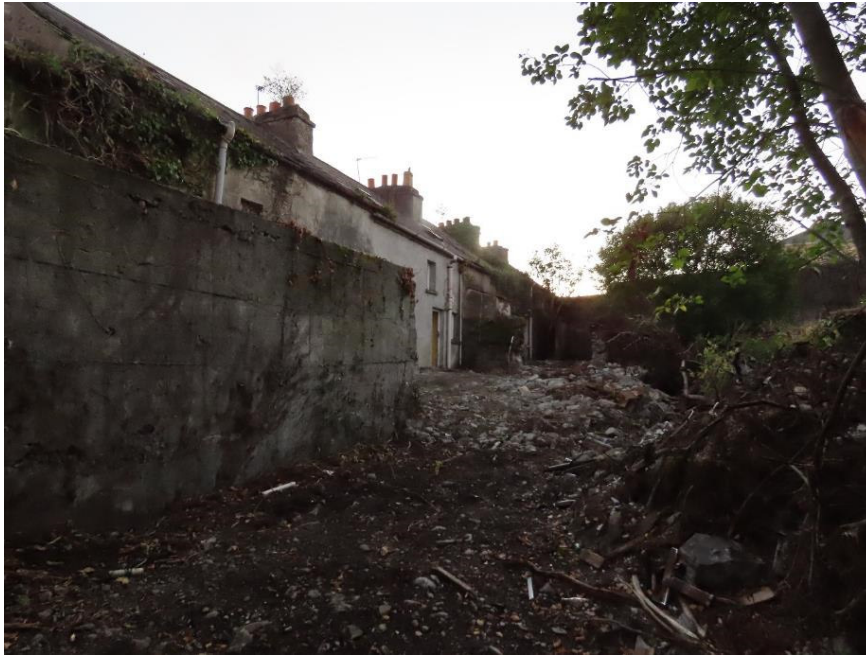
**Photo 69** – dawn survey conducted to rear of terrace on Dunlo Hill

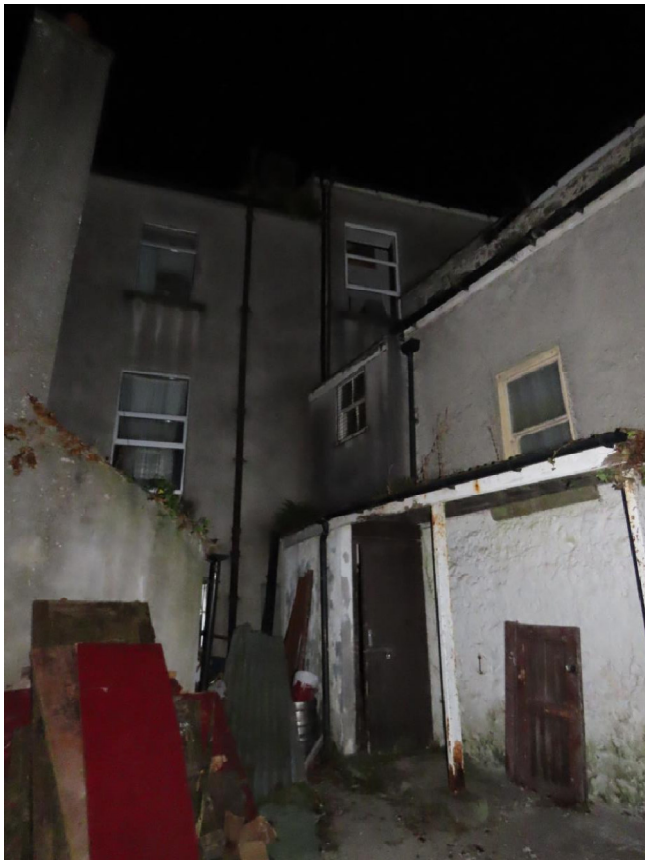
**Photo 70** – dusk survey conducted to rear of Dooley's pub
